Sediment replenishment combined with an artificial flood improves river habitats downstream of a dam

Severin Stähly¹, Mário J. Franca^{2,3}, Christopher T. Robinson⁴ & Anton J. Schleiss¹

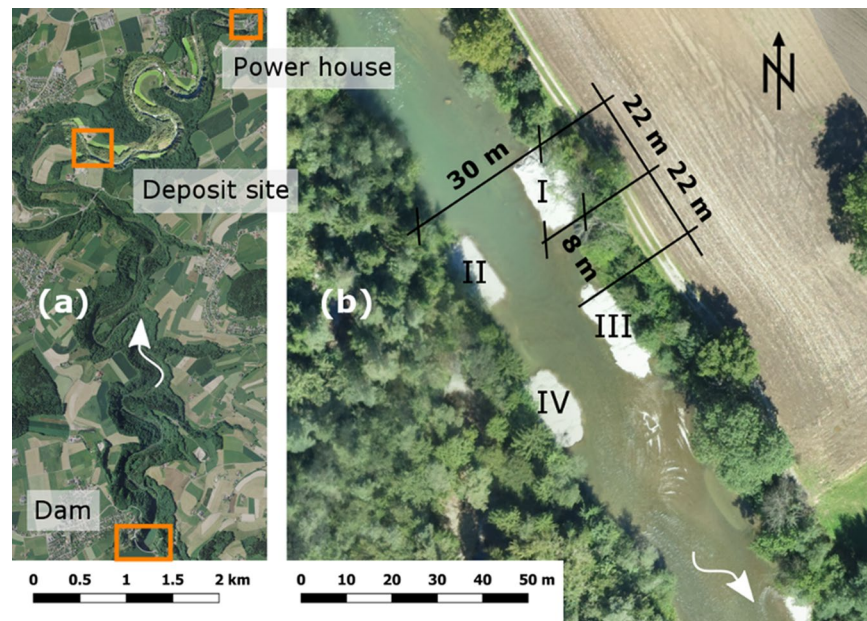
Figure 1. (a) Replenishment site and the locations of the dam and power house, background Geodata © swisstopo. (b) Configuration of the four sediment deposits in the Sarine River, background © Research unit Ecohydrology, ZHAW. The distance between the deposits was about a deposit length, the shift between the deposits on the left and the right bank is half a deposit length. The height of the deposits was ca. 1.5 m above the initial river-bed. The numbering refers to the name of the deposits from upstream to downstream: deposit I, II, III and IV.

In addition to the flood pulse, four sediment deposits were added to the river 9 km downstream of the dam (coordinates 46°45′29.21″N, 7°06′11.47″E; Fig. 1a) with a total volume of 1000 m³ (Fig. 2). The deposit lengths as well as the distance between deposits on the same river bank were slightly less than the river width (around 22 m, Fig. 1b). The mid-channel distance available for flow, in between deposits, was roughly half of the river width. The replenished material was excavated from the adjacent alluvial forest on the right bank of the river. The grain size

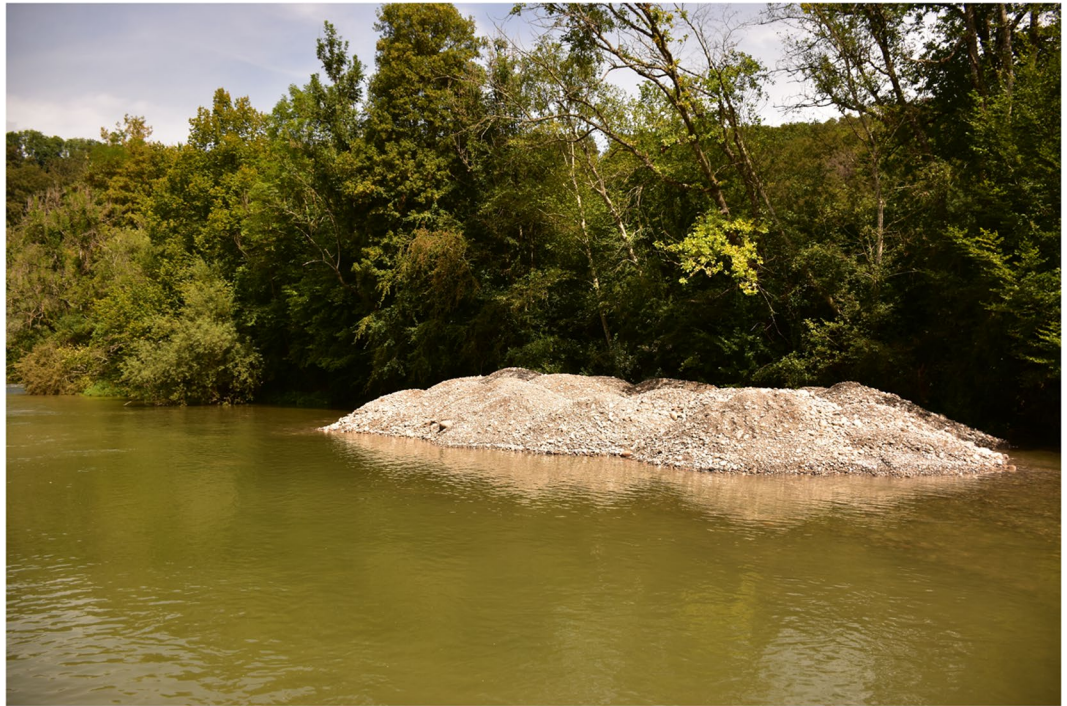
Figure 2. Deposit I in the river before the flood experiment. Its dimensions correspond to ca. $22 \times 8 \times 1.5 \text{ m}^3$ (length, width, height). The material was excavated from the adjacent riparian forest. Image © Elena Battisacco.

Sediment erosion and deposition after the passage of the artificial flood. To follow the movement of the replenished material, 489 stones with a mean diameter of 5.7 cm (corresponding to d_m) and 11.3 cm (corresponding to d_{90}) were equipped with RFID PIT tags and added to each deposit (Fig. 2, see *Methods* for more details). The passage of the two-year flood was not strong enough to erode all the deposits (Fig. 3a). In deposits I, II and IV, sediment was mainly eroded laterally, whereas deposit III was fully eroded.

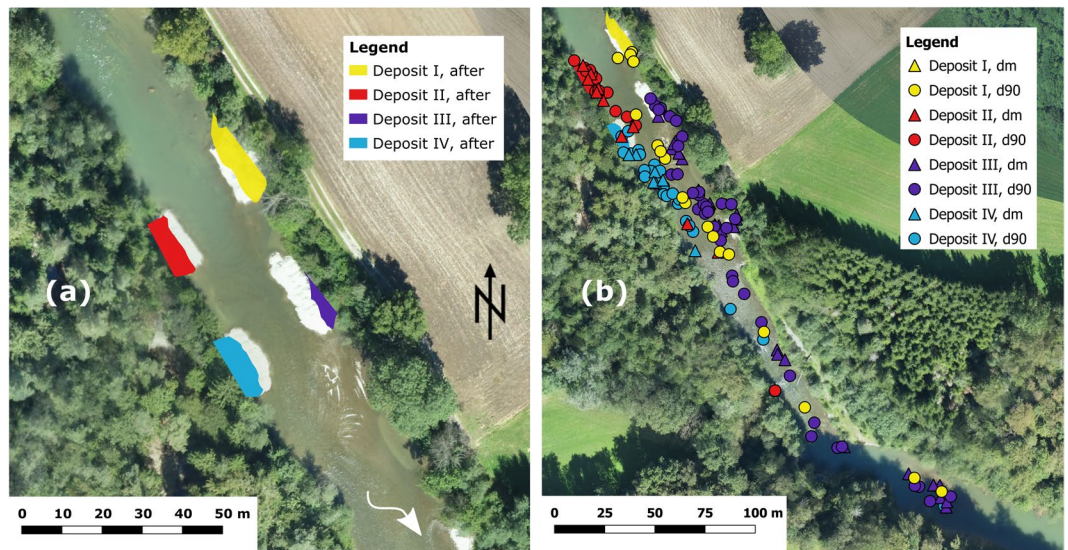
Figure 3. (a) The exposed dry surface of the four deposits before (air-image background © Research unit Ecohydrology, ZHAW) and after (colored areas) the artificial flood event. The residual flow discharge was $3.5 \text{ m}^3/\text{s}$ when the air-image was taken before the flood event and $2.5 \text{ m}^3/\text{s}$ when the dry surface was measured after the flood event. (b) RFID PIT tag equipped sediments detected after the flood event (background © Research unit Ecohydrology, ZHAW).

During surveys made after the artificial flood, 277 (57%) RFID PIT tagged sediments were recovered (Fig. 3b, see *Methods* for details about the detection). A total of 111 tags were detected on the remaining part of the

detected on the left side of the river, whereas the inverse was observed for sediments originating in deposits II and IV (Fig. 3b). The equipped tags settled in clusters, similar to the previous laboratory observations.

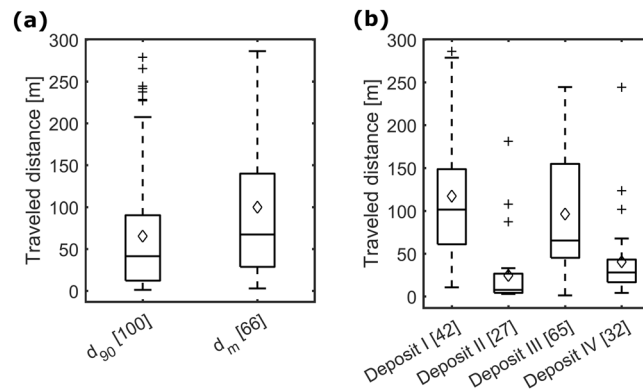
Figure 4. Traveled distances of the RFID PIT tagged sediments which were detected with the mobile antenna after the flood event sorted by (a) size and by (b) deposit of origin (see *Methods for following sediment transport* for details about the detection).

deposits which was not eroded and 166 tagged sediments were eroded and transported downstream. The travelled distance depended mainly on the deposit of origin of the sediment and was always $< 286 \text{ m}$. On average, sediments with the size corresponding to the d_m travelled about 100 m and the sediments with the size corresponding to d_{90} about 65 m (Fig. 4a). However, their maximum transported distance is equivalent. Tagged stones from the deposit I and III were further transported than tags from deposit II and IV (Fig. 4b). Most of the detected tagged stones had deposit III as origin, followed by deposit I, IV and II. Tagged sediments from deposit I and III were all

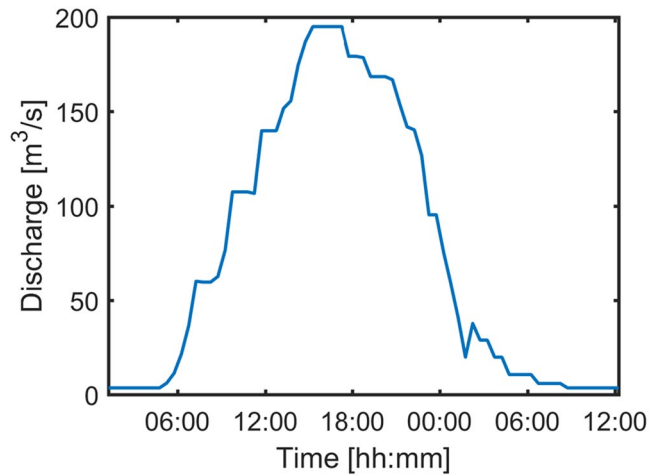
Figure 5. Hydrograph of the flood pulse. The peak discharge of this two year flood was limited by restrictions in the flooding perimeter. The whole flood lasted more than 24 hours starting from 14 September 2016 at 05h00 to 15 September 08h30.

The artificial flood and the replenishment of sediments. A flood pulse with a peak discharge of 195 m³/s, corresponding to a return period of two years, was released from Rossens dam in September 2016. Due to the limitations of the hydrograph (polluted areas near the floodplain could not be flooded), a shape was chosen in which peak discharge was kept for two hours (Fig. 5).

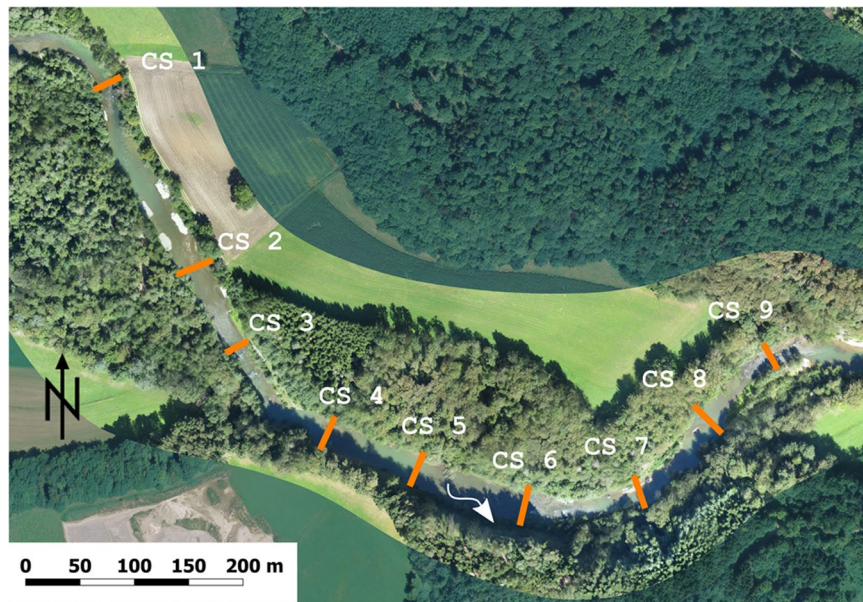
Figure 6. Nine cross-sections (CS) where flow depths and velocities were measured. CS 2–4 correspond to the HMID_{impact zone}, CS 1 and 5–9 to the HMID_{rest zone} (see Table 1). Background © Research unit Ecohydrology, ZHAW.

A 850 m reach was analysed. Measurements of flow depth and flow velocity were made at the exact same locations before and after the flood event, across the river at nine different equally-spaced cross-sections with a distance of about 95 m (Fig. 6). A total of 200 velocity and water depth measurements were taken in the reach, before and after the flood event. The measurement points were equally distributed over the cross sections with a 1 m spacing. Instantaneous flow velocities were measured with a Handheld-ADV (FlowTracker manufactured by SonTek) at 60% of the flow depth. Flow velocities were averaged over a period of 45 s, with a measurement frequency of 1 Hz, which proved to provide a robust mean value. Flow depths were measured with the scale on the vertical bars of the FlowTracker equipment. The location of the sampling points was recorded with a differential GPS. An analysis of statistical convergence revealed that the results obtained with 200 points surveyed in the 850 m in the Sarine river are sufficient. Detailed information concerning sampling and data sufficiency can be found in literature³⁴.
