## Perspective

## Possible aerosol transmission of COVID-19 associated with an outbreak in an apartment in Seoul, South Korea, 2020

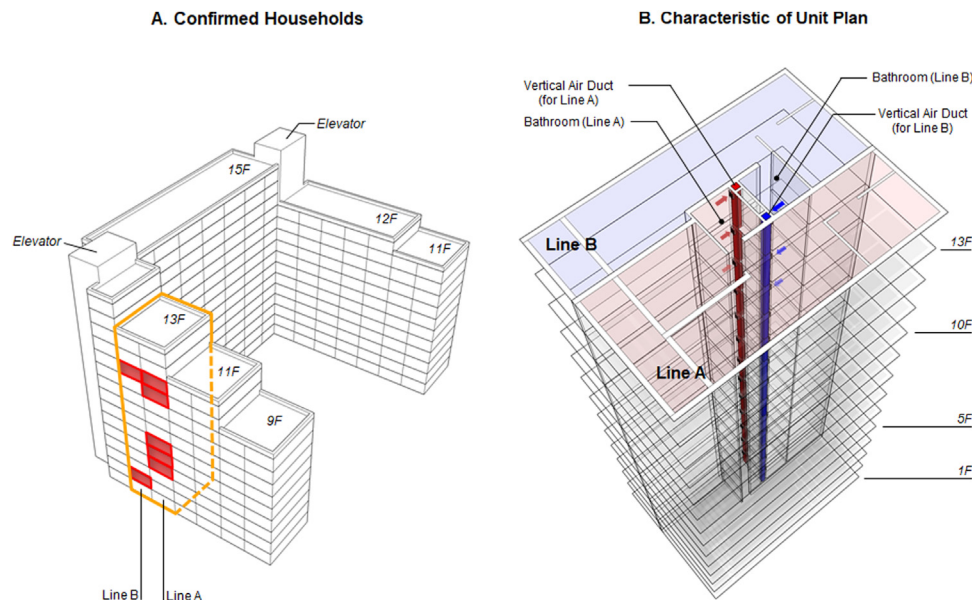
**Figure 1.** Structure of the apartment building where the infection outbreaks occurred in two vertical lines. (A) Confirmed units, (B) Characteristics of the unit plan.

The apartment where the outbreak occurred was built in 1988 and consisted of 9–15 floors. Fifteen to twenty-one households are living along the hallway on each floor. Two elevators and entrances are located at both corners of the building (Figure 1A). In this apartment, a natural ventilation shaft is located along each vertical line from the bottom to the rooftop. Each shaft is connected to the units within the same vertical line through the blowhole at the bathroom (Figure 2B).

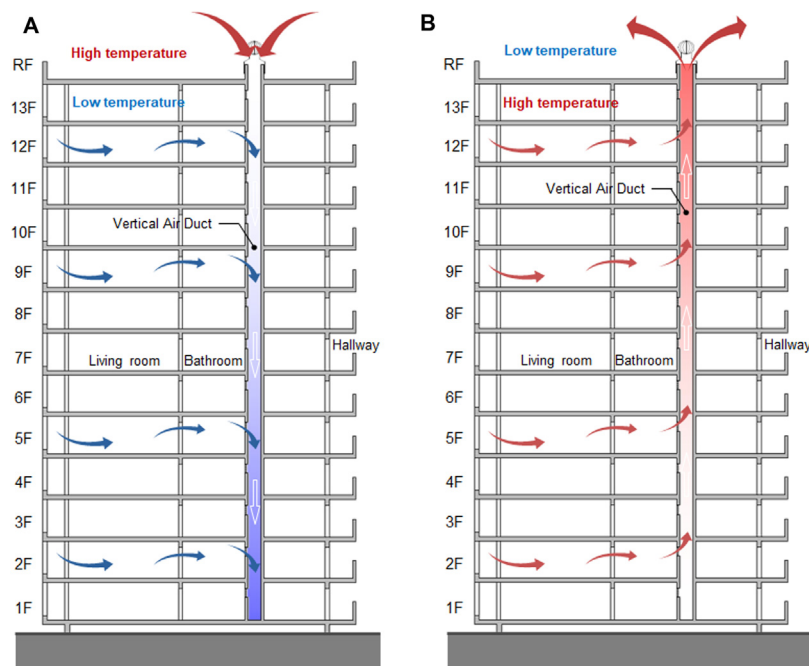
**Figure 2.** Diagram of the airflow in the air duct. (A) Stack effect (winter), (B) Reverse stack effect (summer).

because this building was built before the installation of an exhaust fan with a backdraft damper in bathrooms became compulsory. Thus, there is no physical block for the air to enter the room from the air duct. This structure can easily make a stack effect that refers to the vertical movement caused by the difference in indoor and outdoor air density due to the difference in temperature inside and outside the building. In this case, patient no. 7 from the 10th floor, whose symptom appeared first, is suspected as the infection source in this cluster, which means that the infection may have spread from the 10th floor to the upper floors and mainly downstairs. The variation in the direction of air movement in the vertical space depends on the season. In summer, as the temperature inside is lower and the density is higher than the outside, the air inside the building moves to the lower part by receiving a downward force; this is called the reverse stack effect (Mijorski and Cammelli, 2016). For example, Lee et al. (2017) showed that external coarse particles ( $<10 \mu\text{m}$ ) and fine particles ( $<2.5 \mu\text{m}$ ) were able to travel from upper to lower levels through the vertical channel by a reverse stack effect in summer, which supports the possible viral transmission of the aerosol through the ventilation system.

The apartment is vertically connected with a shaft through blowholes at the bathroom. Besides, units do not have a fan

Previous research has shown that SARS-CoV-2 can travel longer through aerosols, similar to SARS and MERS (Setti et al., 2020). The virus was stable with a half-life of more than one hour (van Doremalen et al., 2020), enough to be inhaled by susceptible individuals, causing infection and further spreading the disease. Thus, we infer that the first infected person probably released the virus during a shower in the bathroom by coughing, breathing, singing, or flushing around the time when the symptom arose (Yao et al., 2020). The virus may combine with water vapor and become aerosols in the humid environment, which favors the transmission and survival of SARS-CoV-2 (Raines et al., 2020; Zhou et al., 2007). The mechanical ventilator in the bathroom may force exhaust the aerosols to the air duct, and these spread from the 10th floor to the upper and mainly lower floors in a line by the reverse stack effect
