Sacroplasty: A Treatment for Sacral Insufficiency Fractures

Summary: Sacral insufficiency fracture is a debilitating injury for which no active treatment is currently available. We present three consecutive cases of elderly patients with sacral insufficiency fractures whose symptoms were relieved immediately by treatment of the fractures by polymethylmethacrylate injections, a so-called sacroplasty.

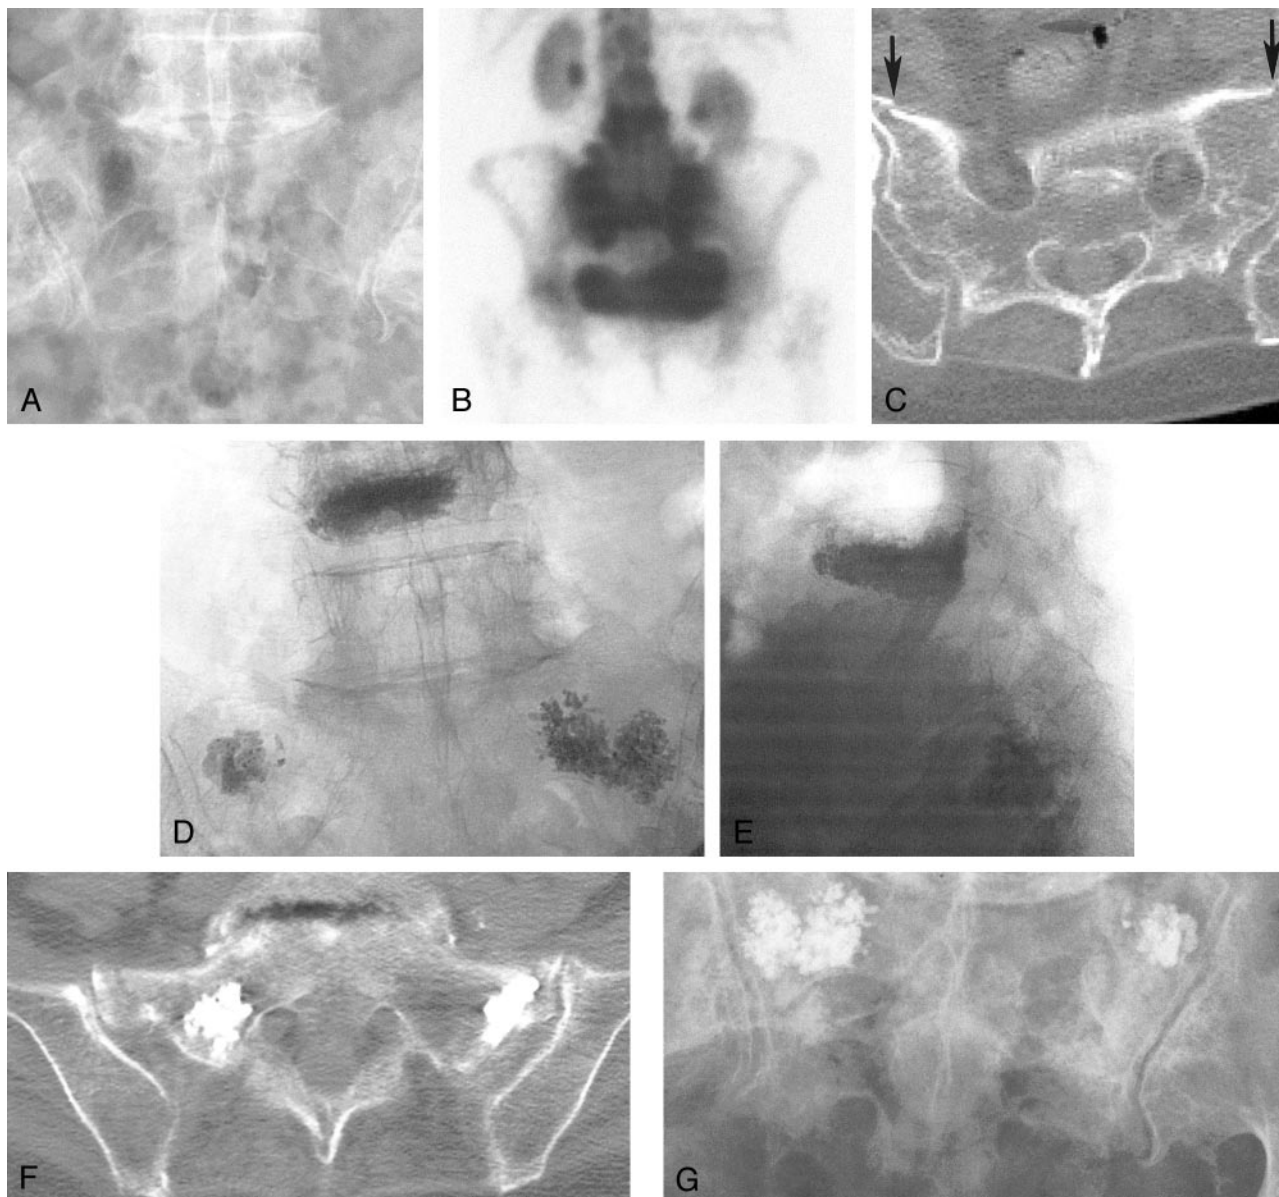
FIG 1. Case 1, a 76-year-old woman with low back pain.

A, Pelvic radiograph shows degenerative lumbar changes. Note, however, that the sacrum is unremarkable.

B, Bone scan shows the H sign diagnostic of a sacral insufficiency fracture. Prominent renal activity on the scan is a normal finding.

C, Cortical disruption (*arrows*) on a non-contrast-enhanced pelvic CT scan confirms fracture.

D and E, Anteroposterior (D) and lateral (E) fluoroscopic images show cement in the L4 vertebral body and cement bilaterally in the sacral ala. The lateral view illustrates the difficulty with visualization within the sacrum during this technique.

F, Postoperative pelvic CT scan shows cement within the bilateral superior sacral ala in the vicinity of the fracture lines

G, Follow-up pelvic radiograph shows the cement within the superior sacrum

A 76-year-old woman was referred for vertebroplasty for intermittent chronic lower back pain recently aggravated by a fall. The severity of her pain necessitated a wheelchair for mobility. During examination, she reported tenderness over L4, but her severe sacral pain dominated her presentation. Although a pelvic radiograph (Fig 1A) was normal, bone scintigraphy (Fig 1B) revealed the classic H sign of a sacral insufficiency fracture in addition to an active L4 compression fracture. As a planning step, preoperative pelvic CT showed sclerotic changes with cortical disruption bilaterally, confirming the sacral insufficiency fractures (Fig 1C). In addition to L4 vertebroplasty, she consented to attempt the sacroplasty alternative.

limited in its usefulness for position confirmation. Using the Parallax injection system (Ezflow Cement Delivery System, Parallax Medical Inc., Scotts Valley, CA), we injected the polymethylmethacrylate cement and barium powder mixture under fluoroscopic monitoring (Fig 1D and E). The overlapping bony pelvis obscured sacral visualization, complicating our assessment of whether the injected cement was contained within the sacrum. A postoperative pelvic CT scan showed cement within the bilateral superior sacral ala, in the vicinity of the fracture lines (Fig 1F). Postoperative instructions included remaining in a supine position for 4 hours, with discharge home afterward.

Pain relief was immediately evident that night, with virtually complete relief of symptoms. At a 1-month follow-up clinical visit, she remained pain free, had regained her independence from a wheelchair and walker, and no longer needed analgesic medication. A follow-up pelvic radiograph showed the cement within the superior sacrum (Fig 1G). By telephone report 16 weeks after the procedure, the patient continued to be pain free with no recurrence of lower back complaints despite two minor falls at home in the interim.

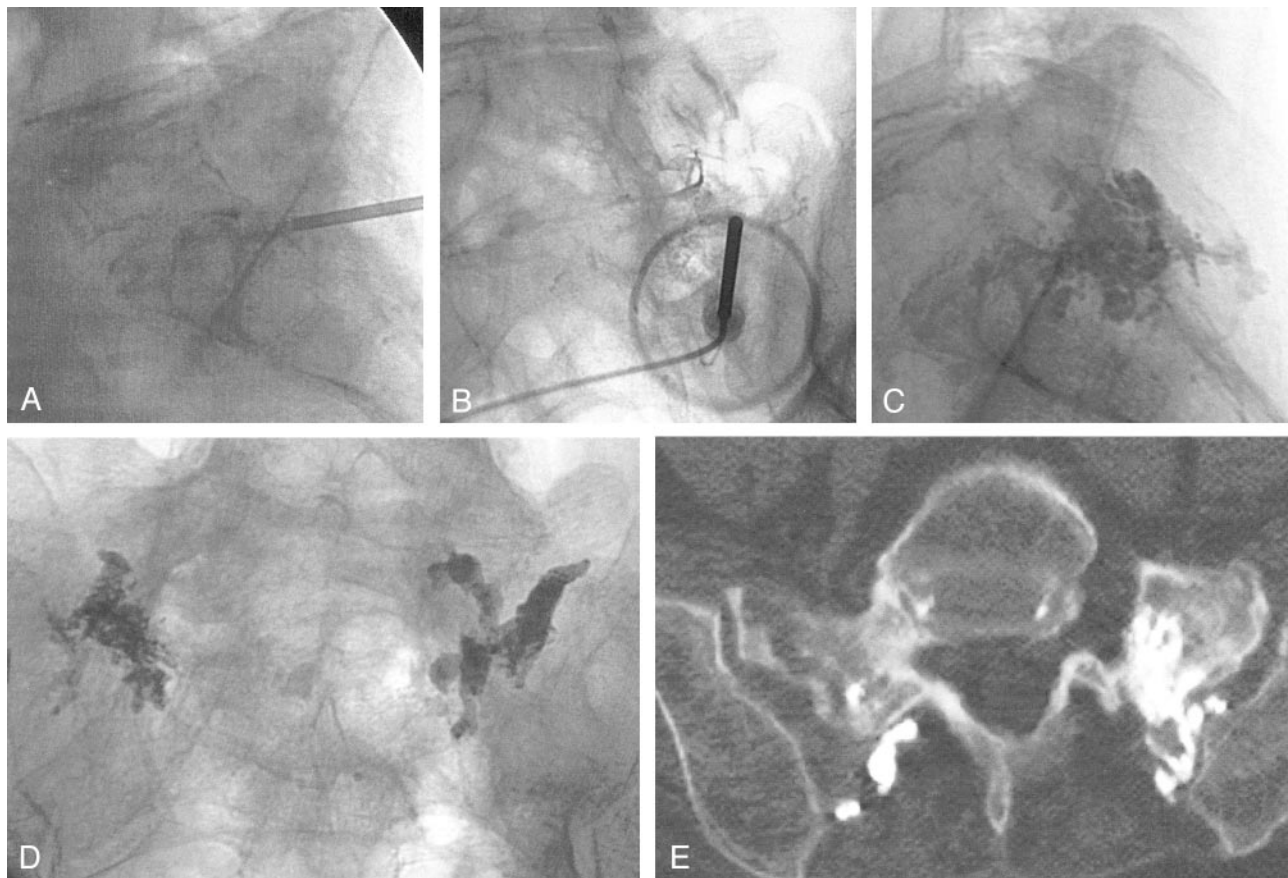
FIG 2. Case 2, a 71-year-old woman with sacral insufficiency fracture.

A and B, Anteroposterior (A) and lateral (B) venograms do not clearly confirm needle tip placement within the sacrum. Again, notice the difficulty in confirming the needle tip location as being entirely intraosseous.

C and D, Anteroposterior (C) and lateral (D) fluoroscopic images show cement within the sacrum.

E, Postoperative pelvic CT scan shows cement within the left sacrum, but the right sacral injection has resulted in a portion of the cement being positioned within the posterior soft tissue

A 71-year-old woman had recurrent sudden-onset lower back pain that she rated 10 out of 10 for several months since falling. This acute pain differed from her chronic lower back pain. She relied on a walker for mobility. MR imaging and bone scintigraphy performed at another institution showed an old T11 compression fracture and bilateral sacral insufficiency fractures. Vertebroplasty at T11 was performed first, although her pain distribution was more clearly related to the sacral area. The subsequent sacroplasty was similar to that performed in our first patient, although venography was attempted for assessing needle placement (Fig 2A and B). Again, visualization of cement within the sacrum was difficult by fluoroscopy alone, and, in retrospect, the volume of cement in each of these first two cases (2–6 mL) was conservative because of increasing operator uncertainty regarding needle location (Fig 2C and D). A postoperative pelvic CT scan showed cement within the left sacrum, but the right sacral injection resulted in a portion of the cement being positioned within the posterior soft tissue (Fig 2E). Pain relief was immediately apparent by the time of discharge, later that same day, and was sustained through her 1-month follow-up clinic visit. She discontinued her pain medications. Her general activities of daily living were much improved and were described to be back to baseline by herself and her family members. In telephone follow-up with the patient 14 weeks after the procedure, she reported she was “wonderfully improved” and pain free in her lower back.

tissues of the buttock or pelvis. To help confirm our needle positioning in the second case, venography was attempted, but it proved unhelpful (13). Because of our limited experience with this procedure, we recommend CT guidance for needle placement; CT might enable greater accuracy for locating the needle tip within the bone adjacent to the fracture zone. In the third case, CT was used for needle placement and fluoroscopy for injection, which proved very satisfactory. A CT fluoroscopy suite would be the ideal environment, providing accurate needle visualization and real-time monitoring of cement injection. In our third case, the portable C-arm fluoroscope simulated this ideal situation. CT alone is insufficient for sacroplasty in our opinion, because the real-time monitoring offered by fluoroscopy is necessary for early detection of cement migration.

In our three cases, no significant complications occurred. In one case, a small amount of cement entered the posterior soft tissue, without any notable complications for the patient. Like vertebroplasty, cement migration could cause venous emboli or neural compromise. These potential complications necessitate real-time monitoring of injections and cautious cement application.

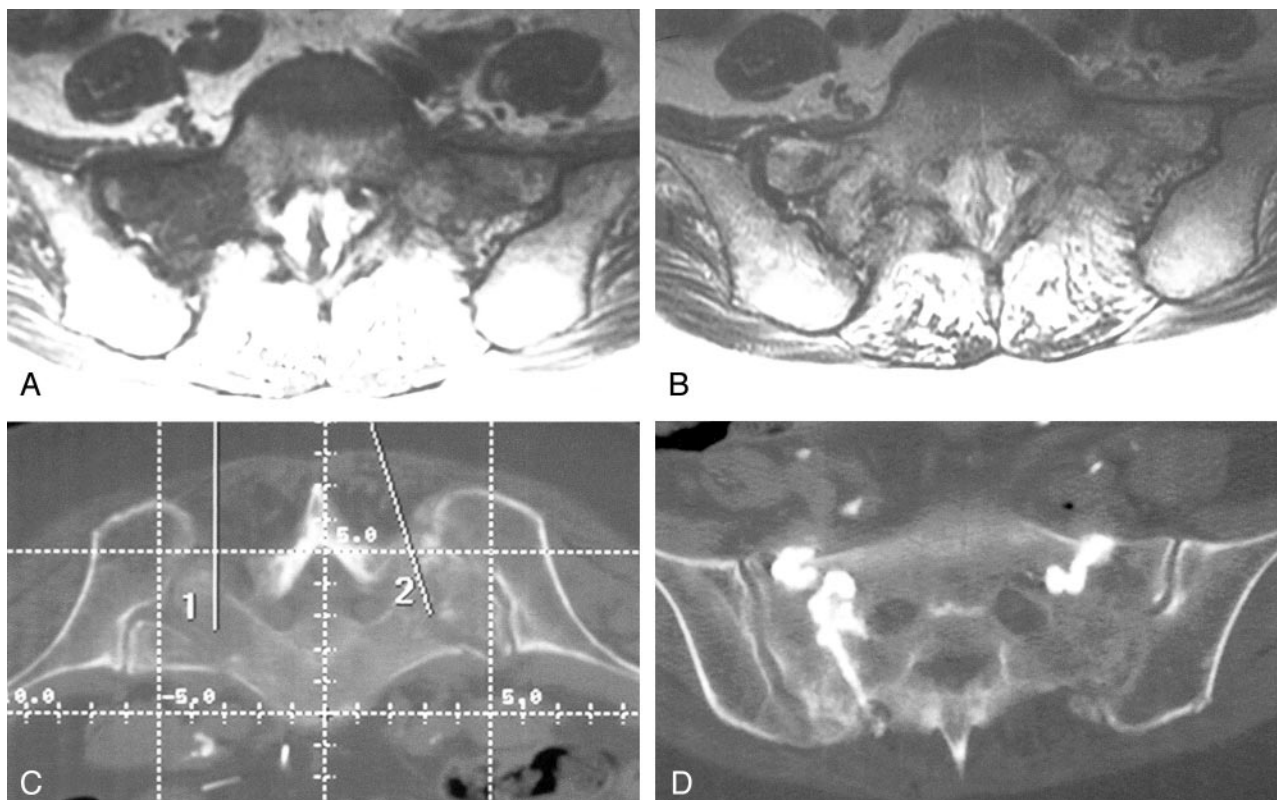
FIG 3. Case 3, a 74-year-old woman with sacral insufficiency fracture.

A and B, Preoperative sacral MR images show low-T1 (A[TR/TE, 450/14]) and high-T2 (B[4000/99]) signal intensity, consistent with the edema from a sacral insufficiency fracture.

C, Pelvic CT scan illustrates the two intended needle paths, simplifying needle placement during sacroplasty.

D, Postoperative CT confirms cement location.

MR images obtained in a 74-year-old bedridden woman with severe lower back pain (Fig 3A and B) revealed edema within the sacrum, consistent with a sacral insufficiency fracture. Sacroplasty was performed in the CT suite, which greatly simplified needle placement (Fig 3C). Needle placement in the sacrum was performed by using CT guidance. A portable C-arm fluoroscope was brought to the CT suite and used to

monitor cement injection. Postoperative CT confirmed the sacral cement placement (Fig 3D). The patient's pain greatly diminished after the procedure, but she was lost to follow-up.
