Neth Heart J (2022) 30:239–240
<https://doi.org/10.1007/s12471-022-01659-x>

Bioprosthetic mitral valve thrombosis

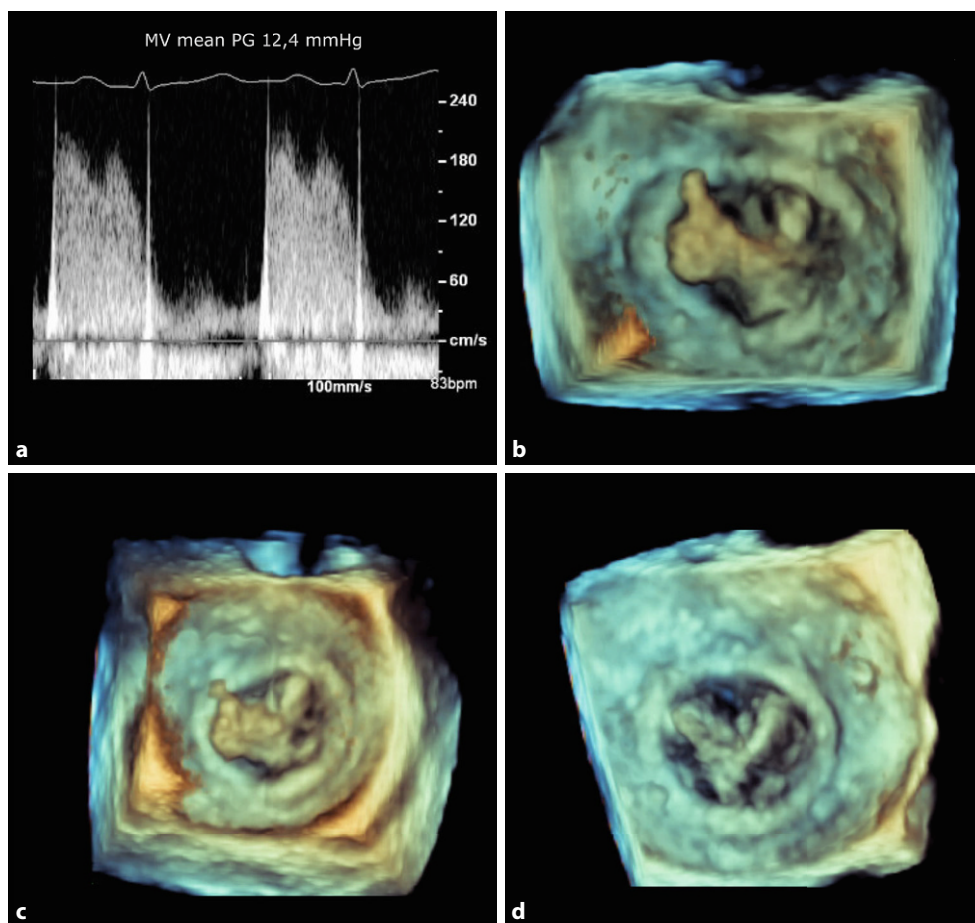
Fig. 1 Bioprosthetic valve thrombosis **a** Elevated transvalvular gradient. **b** Echogenic mass attached to mitral bioprosthesis. **c,d** Gradual decrease of echogenic mass under oral anticoagulant therapy

An 80-year-old woman presented with an ischaemic stroke one year after an uneventful bioprosthetic mitral valve replacement. Transthoracic echocardiography was of suboptimal image quality; however, Doppler interrogation of the mitral valve revealed a markedly elevated transvalvular gradient (Fig. 1a). Transoesophageal echocardiography showed a large, mobile mass, which was attached to the mitral bioprosthesis and mimicked a ‘thumbs-up sign’ (Fig. 1b; see also Video 1 in the Electronic Supplementary Material). As the patient was afebrile and both blood cultures and ¹⁸FDG PET/CT imaging were negative, bioprosthetic valve thrombosis (BPVT) was considered a more likely diagnosis than endocarditis. Patient was declined for surgery because of the high operative risk. Alternatively, treatment with a warfarin derivate was initiated. Follow-up echocardiography showed a gradual decrease of the echogenic structure size over time (Fig. 1c, d; see also Videos 2 and 3 in the Electronic Supplementary Material), with normalization of the transvalvular gradient.
