# Potential of dynamic bacterial communities in the bio-corrosion process: a proof study with surface morphology of metal coupons†

Priyanka Basera, Meeta Lavania

Bio-corrosion is a well-known phenomenon of corrosion caused by bacterial communities. It is considered as a worldwide problem as it causes billion-dollar damages to the pipeline industries (mainly oil and gas) each year. Therefore, this investigation was undertaken to understand the significance of bacterial communities in the bio-corrosion system by studying the physical alteration in the metal surface of coupons through different techniques (EIS, XRD, FT-IR and SEM) and the community identification of consortia responsible for the corrosion. Furthermore, supporting data were obtained from APS reductase assays and DAPI microscopy. The EIS plots suggested that the metal coupons in a biotic system were more prone to corrosion than the coupons in an abiotic system. FT-IR analysis of the biotic system validated the presence of magnetite ( $\text{Fe}_3\text{O}_4$ ), goethite ( $\alpha\text{-FeOOH}$ ) and lepidocrocite ( $\gamma\text{-FeOOH}$ ); the XRD spectrum confirmed the presence of oxide and sulphide of iron ( $\text{F

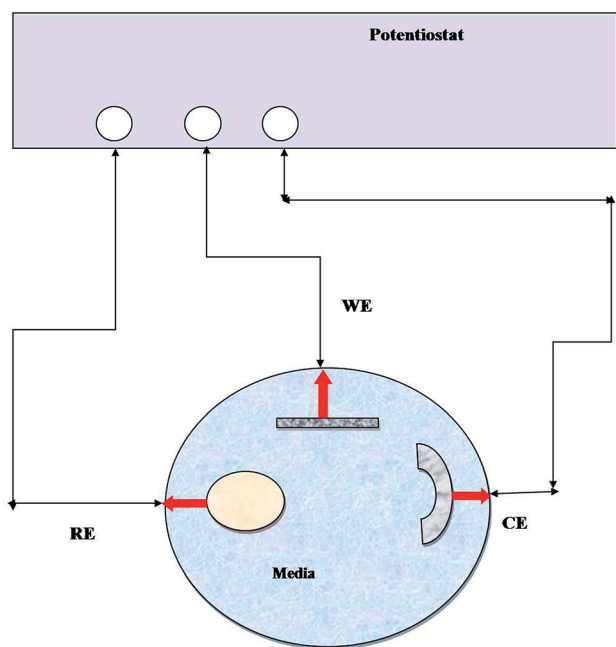
Fig. 1 Line diagram of the EIS experimental setup. RE: reference electrode, WE: working electrode, and CE: counter electrode and medium (abiotic and biotic) served as an electrolyte.

EIS has been widely used to measure the electrochemical properties of corroded surfaces. Experiments were conducted in an electrochemical cell containing a three-electrode system: platinum (counter), calomel (reference) and metal coupon (working electrode) (Fig. 1). The working electrodes (metal coupons) were tested in two ways: (i) abiotic (control) and (ii) biotic (treated) systems, where the medium Postgate B acted as the electrolyte. EIS studies were conducted, and data were recorded at 7 days intervals until 28 days of the incubation period. The impedance was represented by the Nyquist plot (imaginary component of impedance vs. real component), Bode (phase angle vs. frequency) spectra and Tafel plot. EIS was carried out with an AC voltage amplitude of 0.01 V in the frequency range from 0.01 Hz to 10 000 Hz. The data obtained were modelled using the NOVA software.

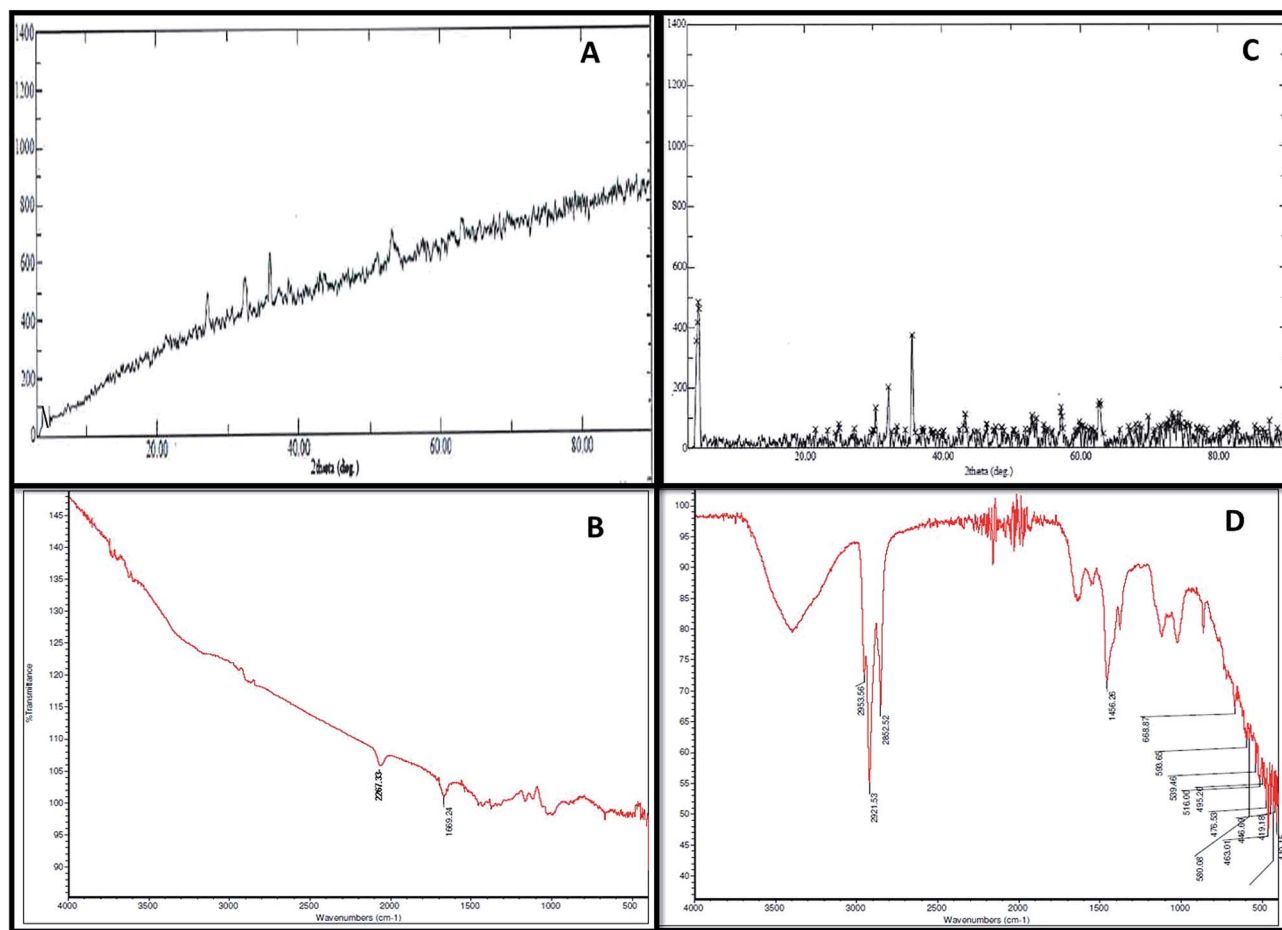
Fig. 3 The corrosive chemical composition produced in the abiotic and biotic systems illustrated by FT-IR and XRD spectra. (A and B) Represent the FT-IR and XRD results for the abiotic system, respectively. (C and D) Show the FT-IR and XRD results for the biotic system, respectively.

XRD and FTIR analyses provided information regarding the chemical composition and functional groups (oxides, sulphides and stretching of compounds) of the corrosive products deposited in the abiotic and biotic systems on the metal surface (Fig. 3(A–D)). The intensity of peaks in the abiotic system (control) was observed to be weak (Fig. 3A). The XRD spectra of the biotic system confirmed the presence of oxide and sulphide of iron ( $\text{Fe}_3\text{O}_4$  and  $\text{FeS}$ ) with high-intensity peaks; the pattern confirmed that the production of sulfide was biogenic in nature (Fig. 3C). Sulfate-reducing bacteria utilized the iron and sulfate (terminal electron acceptors) from the medium and finally altered them to iron sulfide ( $\text{Fe}_x\text{S}_y$ ), which is considered as one of the most corrosive agents for pipelines.<sup>16,25</sup> Similar spectra were reported by Parthipan *et al.*<sup>4</sup> and AlAbbas *et al.*<sup>22</sup> The XRD data revealed the role of bacteria in mineral deposition on the metal surface, which were responsible for coupon corrosion.

As such, no major peaks were observed in the FTIR spectra of the abiotic system (control) (Fig. 3B). Only minor peaks at 1667–2300  $\text{cm}^{-1}$ , which corresponded to the  $-\text{C}=\text{C}$  conjugated

dienes and aliphatic groups, were noticed. Furthermore, the FT-IR spectra of the biotic system demonstrated vibrations ranging between 400 and 700  $\text{cm}^{-1}$ , accounting for the  $\text{Fe}-\text{O}$  stretching, which confirmed the presence of goethite ( $\alpha\text{-FeOOH}$ ) and lepidocrocite ( $\gamma\text{-FeOOH}$ ) (Fig. 3D). The presence of magnetite ( $\text{Fe}_3\text{O}_4$ ) in the sample was shown by the peak at 580  $\text{cm}^{-1}$ . The stretching at higher wavenumbers signified the presence of  $\text{OH}$ ,<sup>26</sup> whereas the stretching observed between 2500 and 3000  $\text{cm}^{-1}$  was assigned to  $\text{C}-\text{H}$  due to the polysaccharide bonds of sugar present in the bacterial biofilm. These compounds are indicated as the notable compounds for corroding a substance. The nature of stretching was described by Kumar and Balasubramaniam; they revealed the presence of similar compounds in Delhi iron pillar rust.<sup>27,28</sup> The data of the biotic system obtained from XRD and FT-IR analyses indicated the presence of these compounds in major amounts, which are corrosive to their respective environments and play major roles in bio-corrosion.

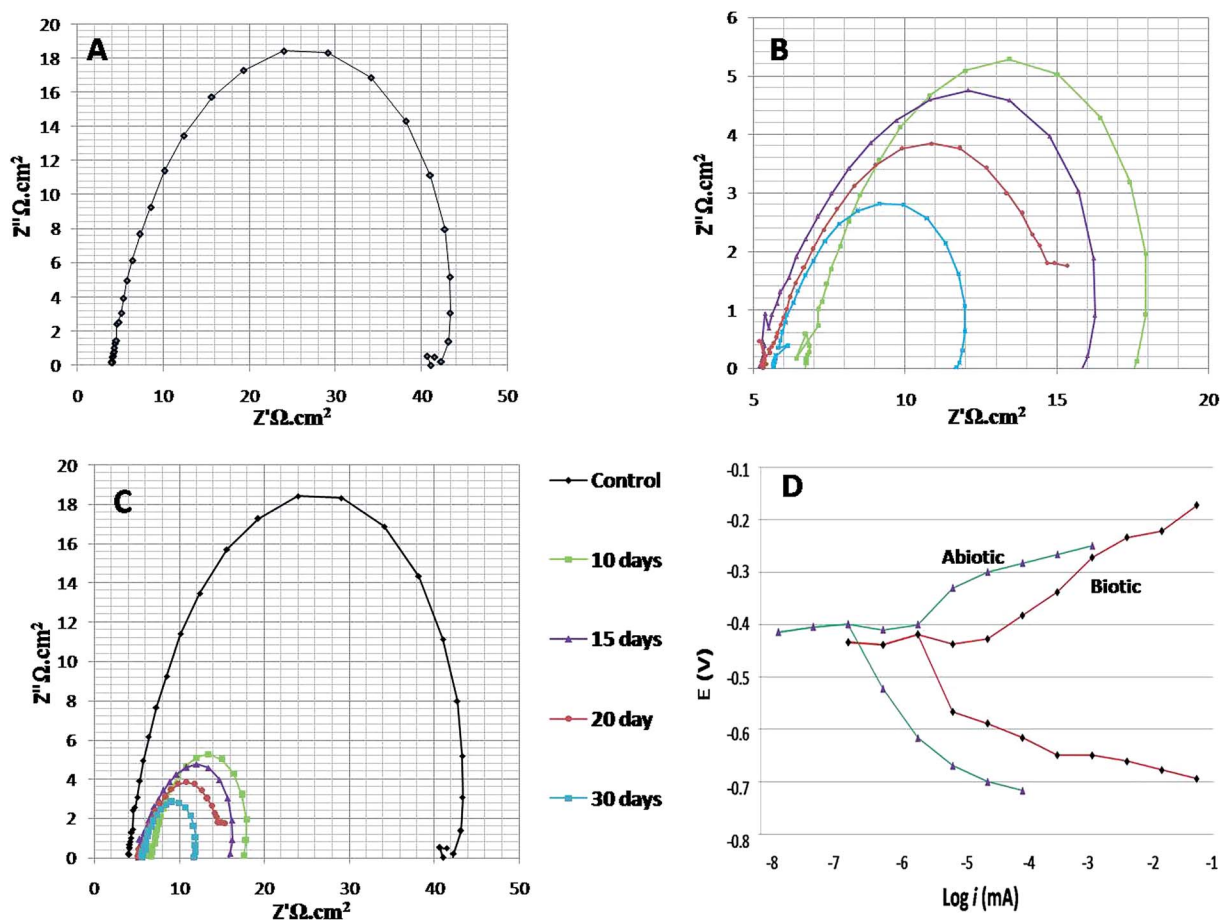
Fig. 4 The Nyquist and Tafel spectra. (A) Illustrates the spectra of the abiotic system, (B) illustrates the spectra of the biotic system for 7<sup>th</sup>, 14<sup>th</sup>, 21<sup>st</sup> and 28<sup>th</sup> days, (C) shows the combined spectra for both abiotic and biotic systems, and (D) elucidates the Tafel plots of the abiotic and biotic systems (on the 28<sup>th</sup> day).

EIS was recorded on every 7<sup>th</sup> day of the 28 days incubation period. The diameter of  $R_{ct}$  was observed to be maximum for control (Fig. 4A); as the environment was abiotic, there was no bacterial activity and the electron transfer was very low. Therefore, in the abiotic system, the chance of electro-biochemical reactions was negligible.

By studying the Nyquist loops of the biotic system, the corrosive nature of the sample can be justified. A significant difference was observed on comparing the diameters of the biotic and abiotic systems; a relatively reduced  $R_{ct}$  value was observed in the biotic system. The reduced diameter signified the role of bacterial activity in metal corrosion.<sup>35</sup> After exposing the coupons for different exposure times, it was observed that, as the incubation period increased, the corrosive behaviour caused by bacteria also increased. The diameter obtained on the

28<sup>th</sup> day was comparatively smaller than the diameter obtained on the 7<sup>th</sup> day of incubation (Fig. 4B and C). Fig. 4D illustrates the Tafel plots of the abiotic and biotic systems, corresponding to the occurrence of anodic and cathodic reactions, and the intersection in the graph gives the corrosion exchange current density. In the case of the biotic graph, the anodic and cathodic values are higher in comparison to the observations for the abiotic graph. This showed that the biotic system contained a corrosive environment. Study reported by Jia *et al.*,<sup>36</sup> similar Tafel plots were obtained; the abiotic system showed lesser corrosion values than the biotic system.

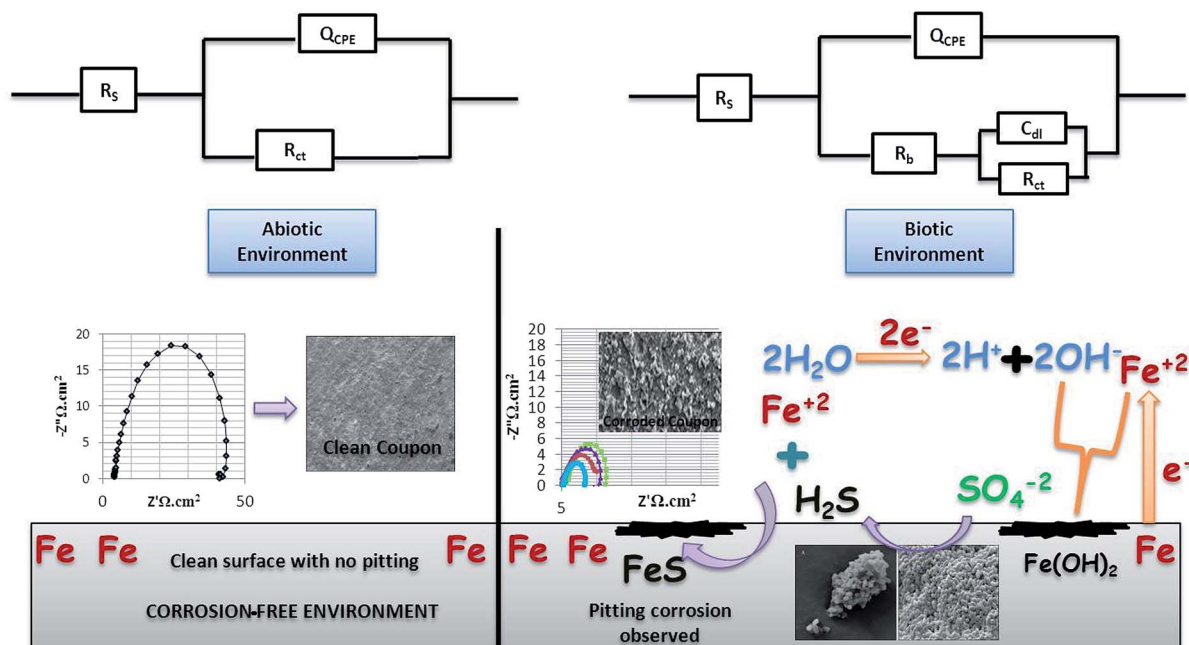
Fig. 5 The bio-electrochemical reactions of the abiotic and biotic systems. The biotic system is a potentially active system.

Fig. 5 shows the difference in the bio-electrochemistry of abiotic and biotic systems with the circuit model, where  $R_s$  denotes the resistance of the solution,  $R_b$  is the resistance created by the biofilm formed in the biotic system, and  $C_{dl}$  refers to the double layer capacitance. In the biotic system, the microorganisms accelerated the corrosion process by generating corrosive products on the metal coupons. The reciprocal of charge transfer resistance ( $1/R_{ct}$ ) is known as the corrosion rate; the smaller the  $R_{ct}$ , the higher the rate of corrosion. It is evident that the diameter of the biotic semicircle decreases, which further reduces the polarization resistance. This suggests that the biotic system has a noticeable effect on corrosion growth by altering the surrounding environment; the metabolites produced (oxides of iron and sulfur) in the biotic system alter the electrochemical properties of the system, which further results in reduced polarization resistance.<sup>37</sup>

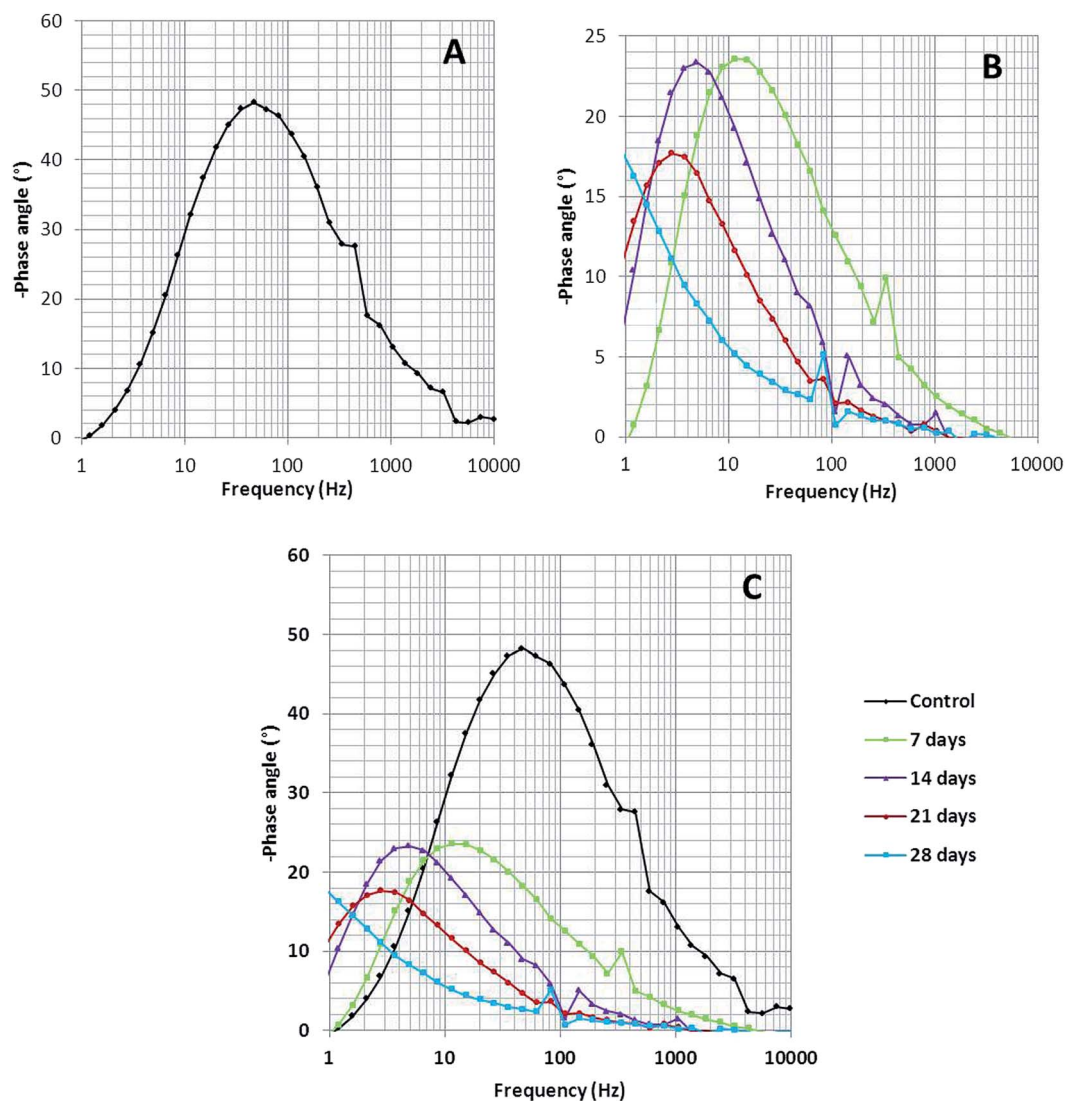
Fig. 6 The Bode phase spectra of (A) the abiotic system and (B) the biotic system on 7<sup>th</sup>, 14<sup>th</sup>, 21<sup>st</sup> and 28<sup>th</sup> days; (C) depicts the comparison of the abiotic and biotic systems.

Bode spectra (Fig. 6) are plotted in the orthogonal axis planes, in which the phase angle (degree) is on the ordinate axis and the logarithm of the frequency (Hertz) is on the abscissa axis. The phase angle spectrum of the biotic system is smaller than that of the abiotic system, which further represents that

the conductivity of the solution sample is high as compared to that of the control.<sup>38</sup> The higher conductivity clarified the presence of more free ions in the system, due to which the bacterial electric pathways become active and this will speed up the process of corrosion.

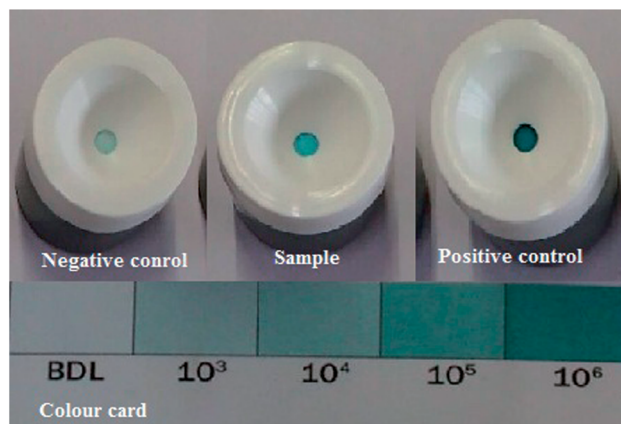
Fig. 7 APS Reductase test. The negative control falls in the BDL range (Below Detection Limit), whereas the positive control and the sample show positive responses towards the reaction. All the experiments were performed in triplicate. The data points are the average of the triplicate  $\pm$  standard deviation (less than 5% of average).

The biotic sample was subjected to the APS reductase assay, which involved a 15 minutes reaction. This assay indicated the presence of APS reductase enzyme in the sample. The kit contained an antibody against the enzyme adenosine-5'-phosphosulfate (APS) reductase, which is common to all strains of SRB. The detection of the enzyme can be examined by the appearance of blue colour on the membrane device after the addition of a chromogen (provided with the kit). Darker shades of blue signify the presence of a higher count of SRB in the sample, which can be inspected by matching the colour card (as per the manufacturer guidelines).<sup>18</sup> For the present analysis, positive and negative controls were prepared. The negative control fell into BDL range (Below Detection Limit), whereas the sample showed a positive response towards the reaction with  $10^5 \pm 1.5$  cell per mL and the positive control showed  $10^6 \pm 1.5$  cell per mL bacterial count, as depicted in Fig. 7.

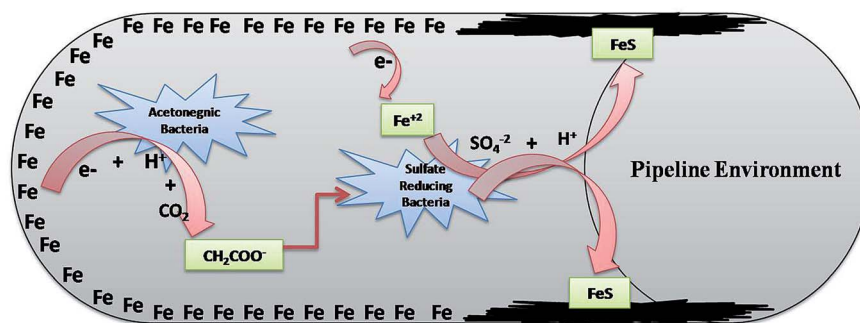
Fig. 9 The synergistic effect of the anaerobic bacterial community, where the by-product of one species acts as a carbon source for the other existing species.

SRB are the eminent anaerobic bacterial domains for establishing detrimental aspects in pipeline industries.<sup>45,47</sup> Bio-corrosion in the pipeline sector is considered as a complex process of multiple reactions. Fig. 9 depicts the line diagram of diverse bacterial communities exacerbating the corrosion process by releasing their metabolic by-products.<sup>2</sup> The pipeline environment acts as a favourable atmosphere for the metabolic growth of bacteria. It contains hydrocarbons and moisture, which are suitable conditions for bacteria to proliferate; they

show synergistic behaviour with other bacterial communities, where the by-products (small volatile fatty acids) of one species act as the carbon source for other species.<sup>5,13,48</sup> As reported by Ilhan-Sungur *et al.*,<sup>49</sup> *Clostridium sp.* can show a corrosive effect with *Desulfovibro sp.* by providing the electron donor “hydrogen” to them. In this way, they support each other and accelerate the process of bio-corrosion. The data obtained from this analysis indicated that a mixed culture has a great potential towards bio-corrosion.

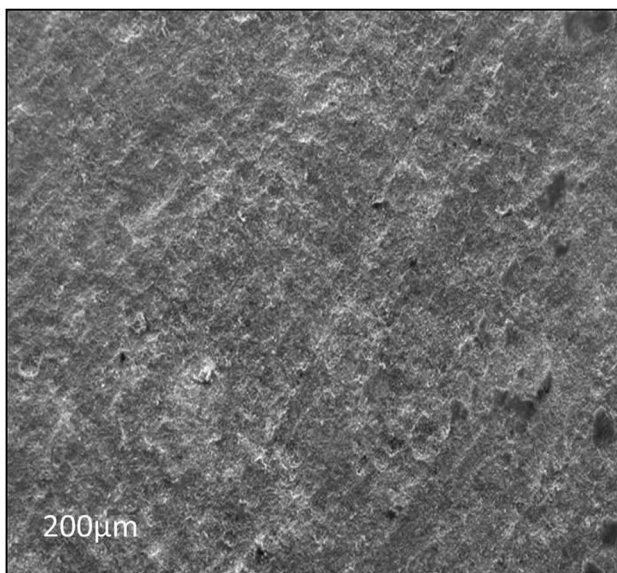
Fig. 11 The SEM image of the abiotic system, showing that the metal coupon surface is cleaned after the 28<sup>th</sup> day of incubation.

Furthermore, the level of the corrosive nature of samples was indicated by the scanning electron micrographs of the biotic coupons (Fig. 11–13). Fig. 11 represents the nature of the abiotic system (coupons in a sterile medium), whereas Fig. 12 and 13 illustrate the effect of the biotic system on the metal surface and the bacterial community responsible for corrosion. With respect to appearance, a significant difference was observed while comparing the coupons of the abiotic and biotic systems. The coupons in the abiotic system appeared clean and clear as compared to the coupons in the biotic system. In the biotic system, the bacterial community almost fully covered the coupon surface. While examining the images in Fig. 12(A–E), microscopic cracks and pits can be noticed, as indicated by the red arrows and boxes. Previous studies illustrated that corrosive bacterial species corroded the surfaces of the coupons by

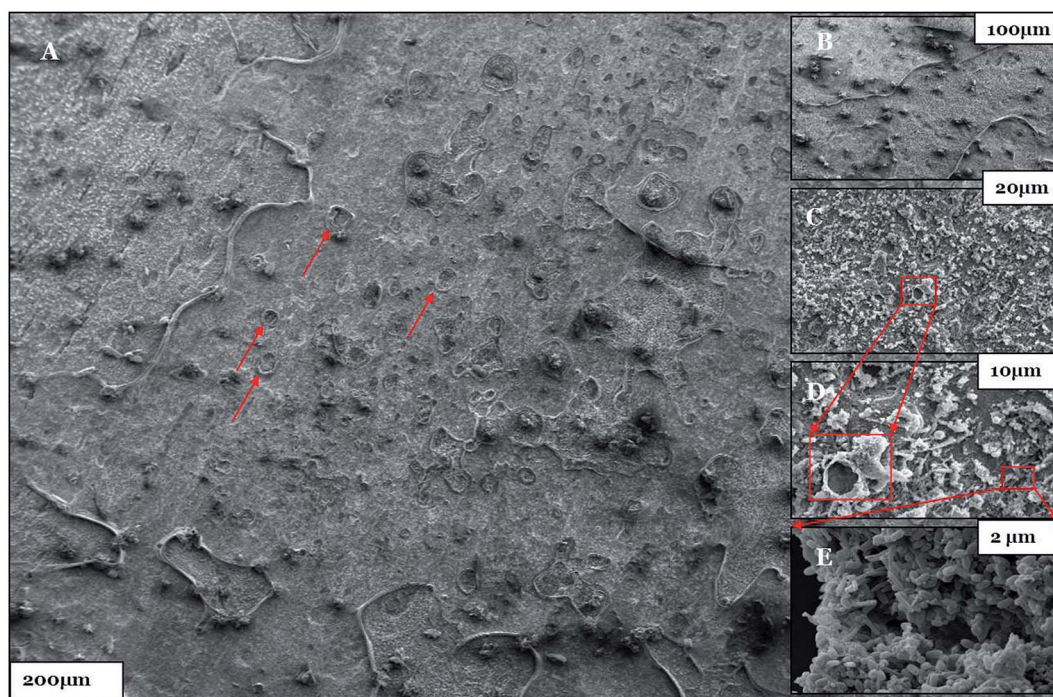
Fig. 12 (A–E) The SEM micrographs of the biotic system after the 28<sup>th</sup> day of incubation. Pit holes are shown by the red arrows and boxes.

producing large amounts of corrosion products mainly composed of iron oxide and an extracellular polymeric substance (EPS). Bacterial EPS mostly comprises polysaccharides, proteins, nucleic acids, phospholipids and humic substances. It supports the bacteria for holding on to the metal surface and is thought to play a significant role in the corrosion process.<sup>5,52,53</sup>

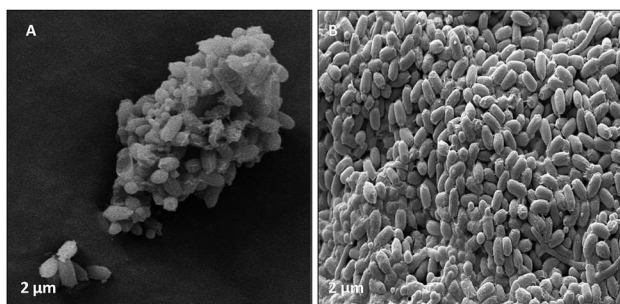
Fig. 13 (A) Illustrated the bacterial species had a cumulative effect on bio-corrosion. (B) Demonstrated the morphology (rod shape) of bacterial community associated with bio-corrosion.

Fig. 13 illustrates that bacteria work in a cumulative way to accelerate corrosion in the surrounding environment. By accumulating, they reduce the surface area with respect to the environment.<sup>54</sup> The possible reason for the pits could be elucidated by associating the data obtained from EIS, XRD, and FTIR as well as the APS reductase assay and community analysis, which provide evidence that the consortium contains corrosive anaerobic bacterial species and assists the process of corrosion synergistically.<sup>55</sup>
