Supplemental materials:

Caption for supplementary figures and videos.

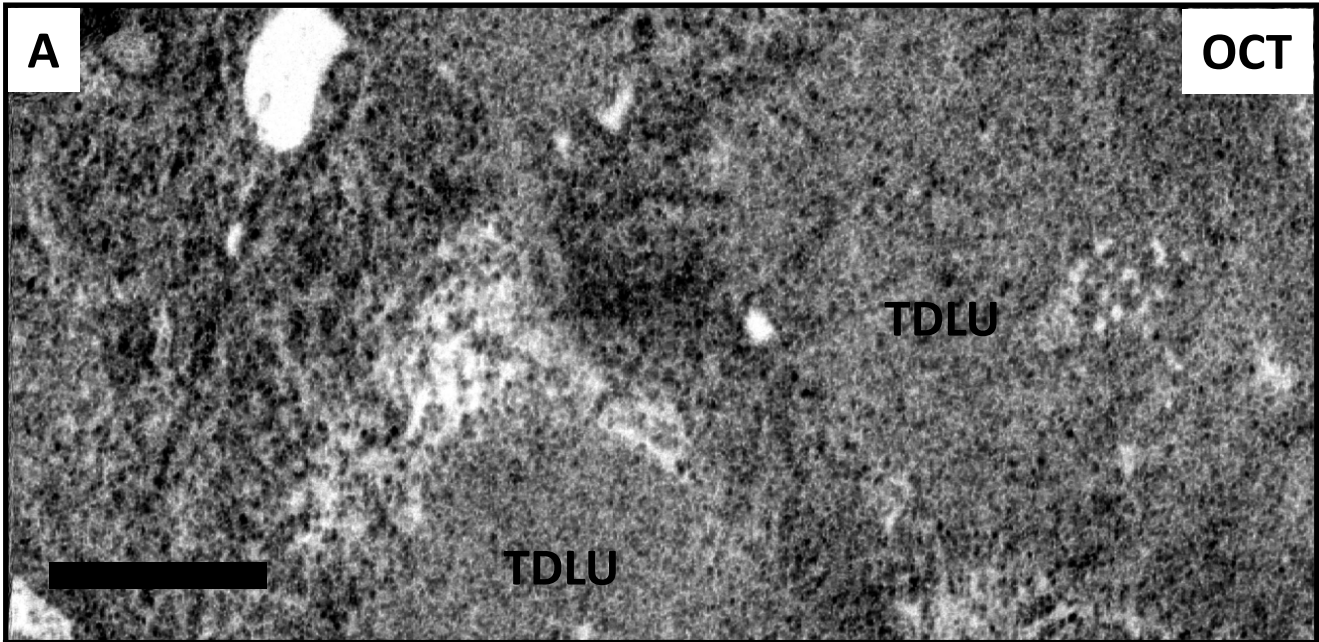
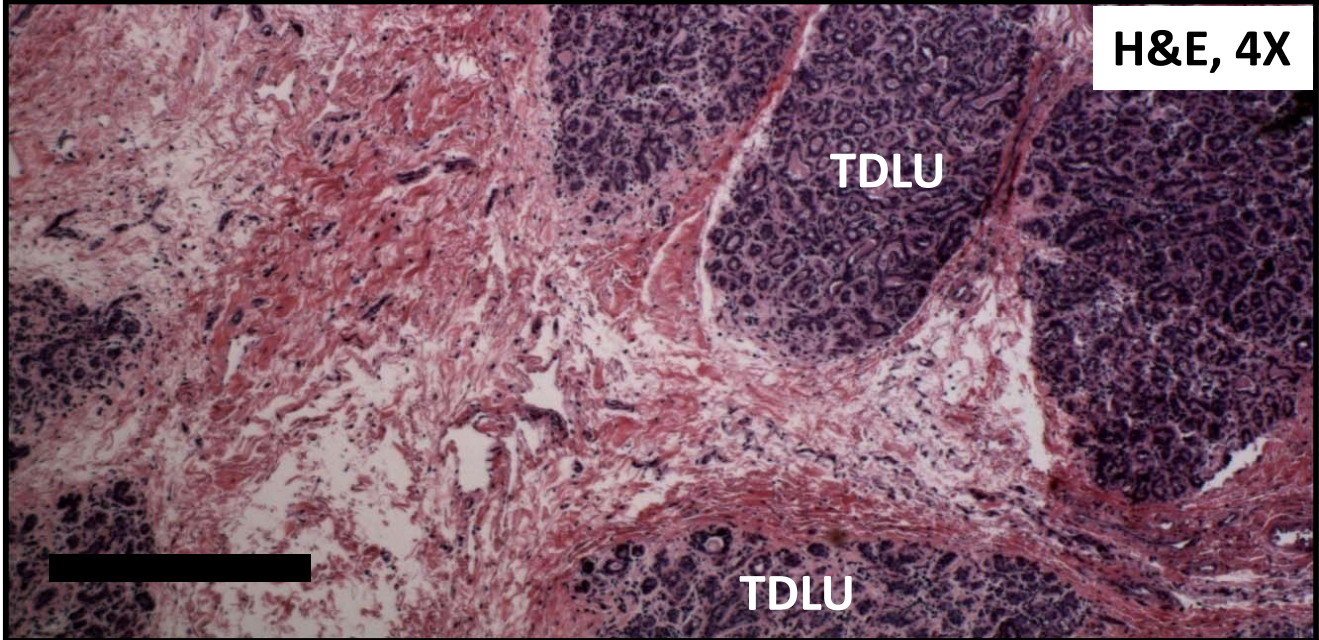
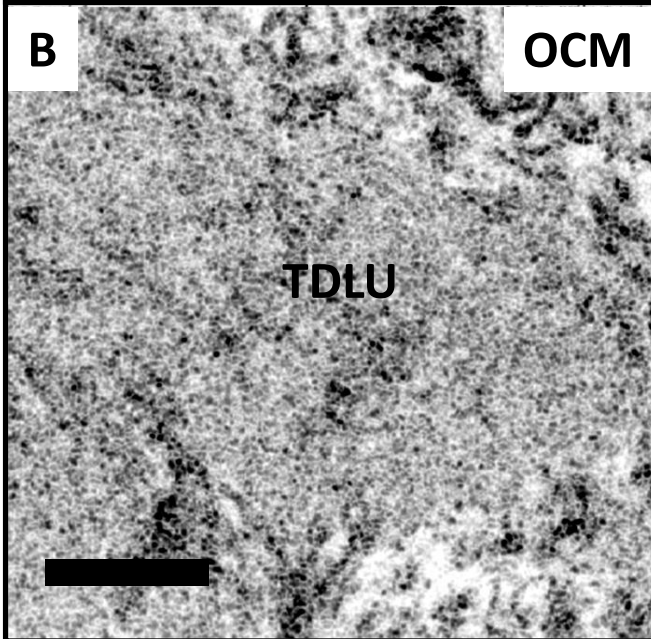
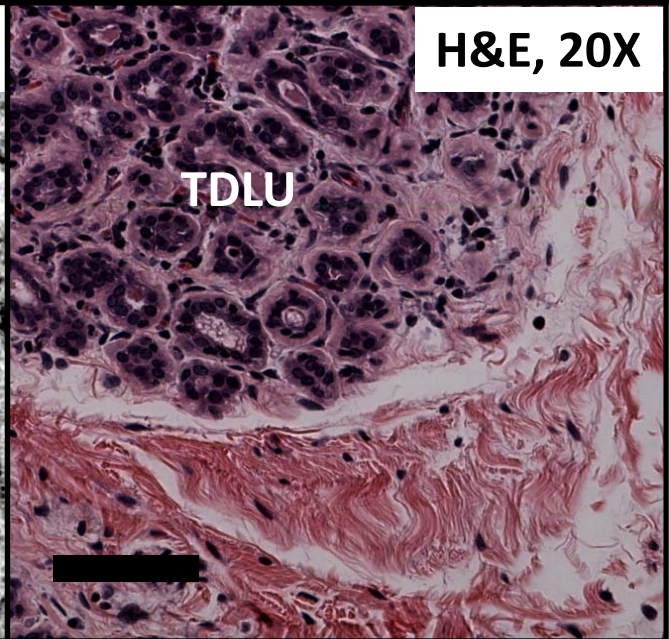
Figure S1. Benign breast tissue with confluent terminal duct lobular units (TDLUs) are difficult to distinguish from invasive carcinoma (Figure 4D). OCT image was reconstructed from ~200 um beneath the tissue surface. OCM image was ~40 um beneath the tissue surface.
