Supplemental

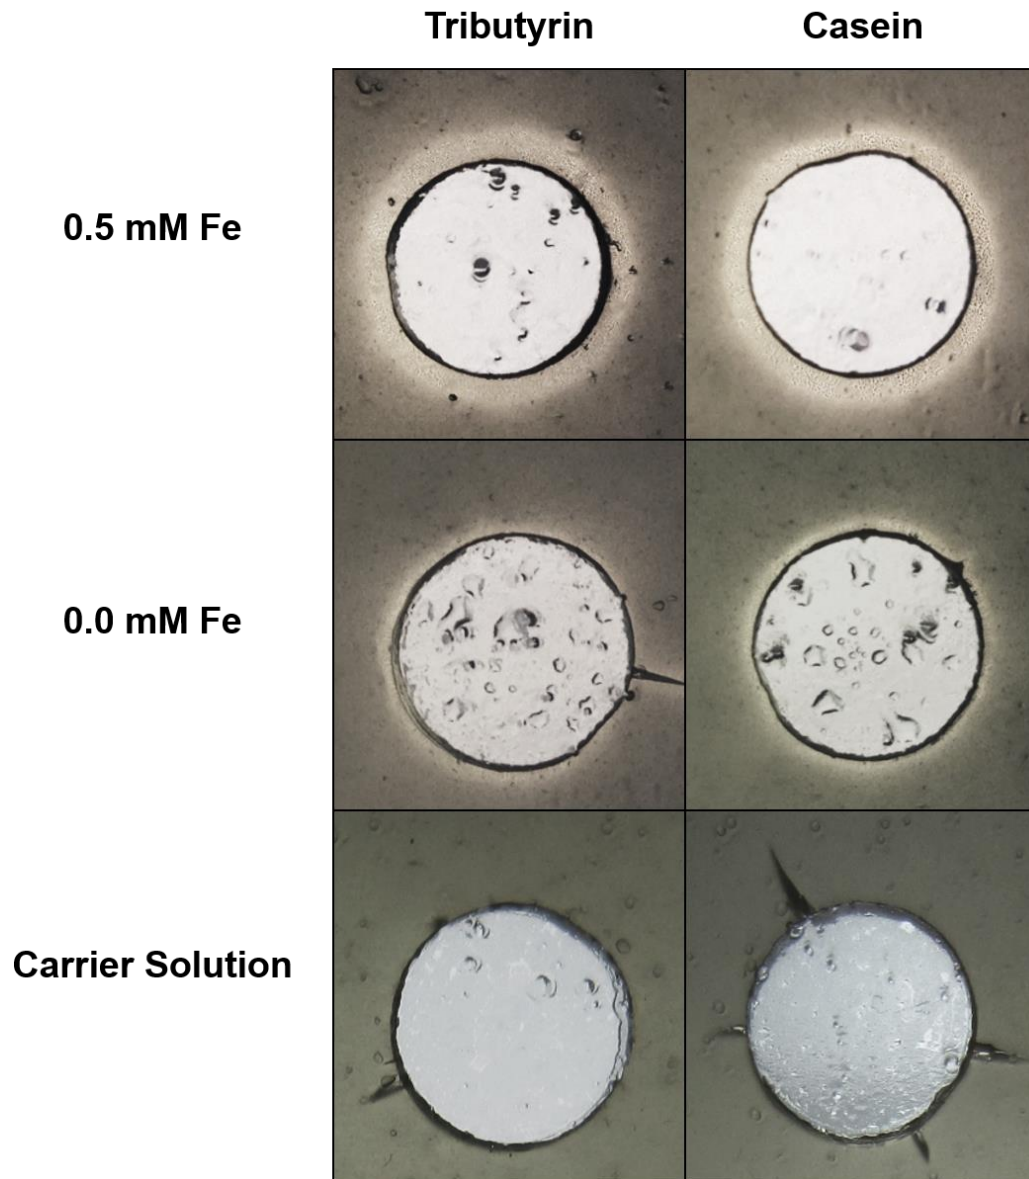
Supplemental Figure 1: Tributyrin and Casein Degradation Assay Plates. Wells in tributyrin or casein agar plates assessed for areas of clearing after exposure to supernatant liquids from 0.5 mM iron treated biofilms, untreated biofilms or carrier solution. Halos around the wells denote substrate clearing. The diameter of each well is 10 mm, and depth is 2 mm.
