Supplemental Figure 1. ⁶⁴Cu-ATSM PET/MR images of a representative rabbit shown in Figure 2 4 wk post injury. The transverse (top) and coronal (bottom) view of the PET images (A, D), T₁-weighted MR images (B, E) and fused PET/MR images (C, F) indicated a significantly elevated uptake of ⁶⁴Cu-ATSM in the IF as compared to the SF. Red arrows point to injured femoral artery; blue arrows point to sham-operated femoral artery.

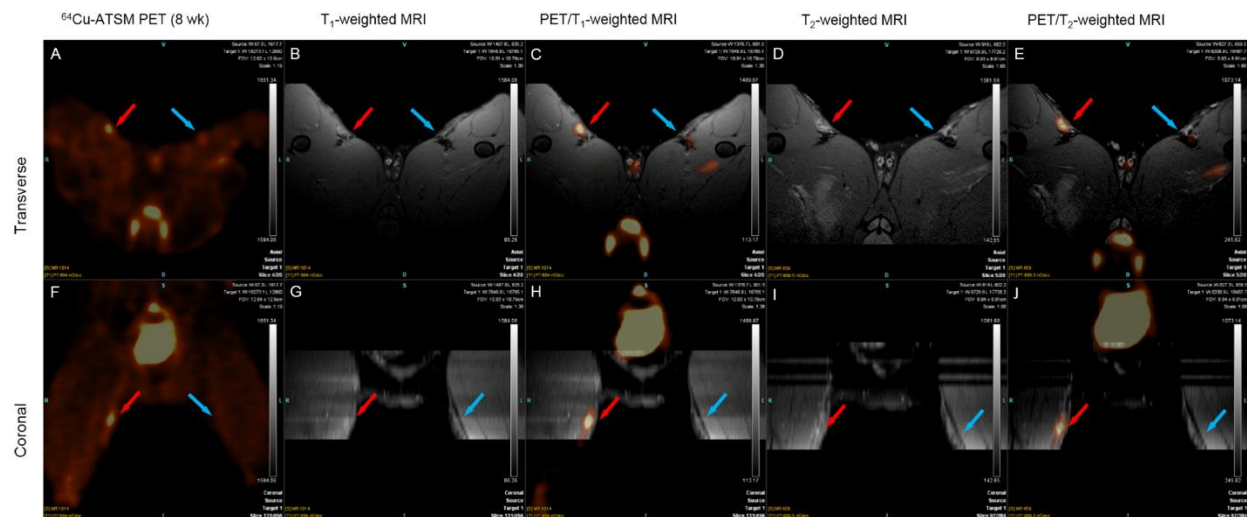
Supplemental Figure 2. ^{64}Cu -ATSM PET/MR images of the same representative rabbit shown in Figure 2 8 wk post injury. Significant uptake of ^{64}Cu -ATSM was also found in the IF as compared to the SF as shown in transverse (top) and coronal (bottom) views of the PET images alone (A, F), fused either with T₁-weighted MR images (MR: B, G; fused PET/MR: C, H) or T₂-weighted MR images (MR: D, I; fused PET/MR: E, J). Red arrows point to injured femoral artery; blue arrows point to sham-operated femoral artery.

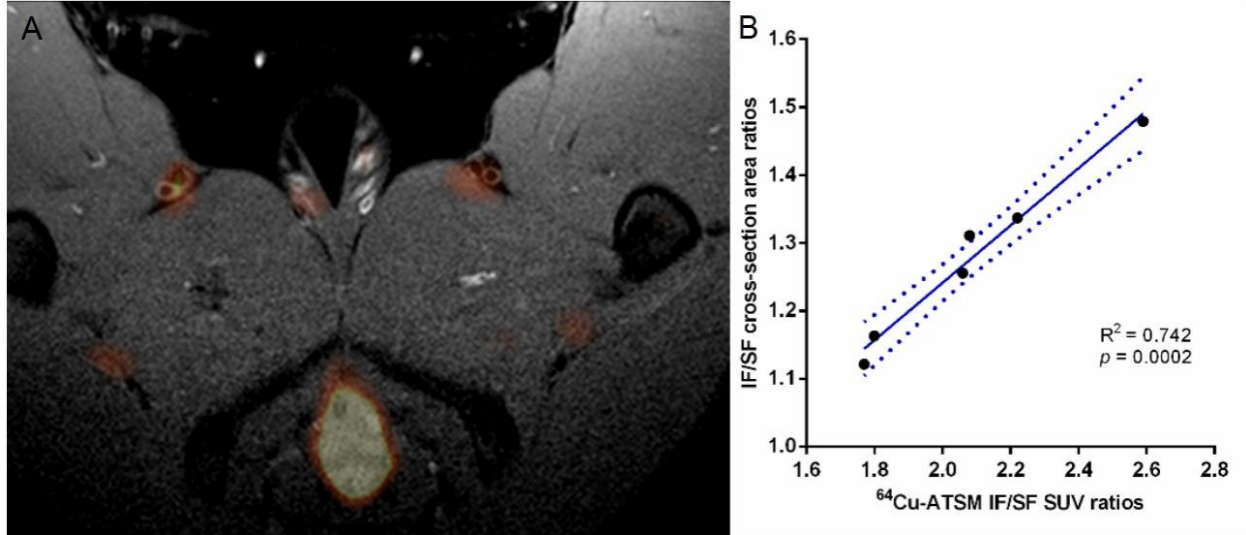
Supplemental Figure 5. (A) Fused PET/MR image suggests a thickened arterial wall and elevated uptake ^{64}Cu -ASTM in the IF as compared to the SF. (B) Linear regression analysis shows that ^{64}Cu -ATSM PET IF/SF SUV_{mean} ratios are positively correlated to IF/SF cross-section area ratios measured in T₁-weighted MRI images.

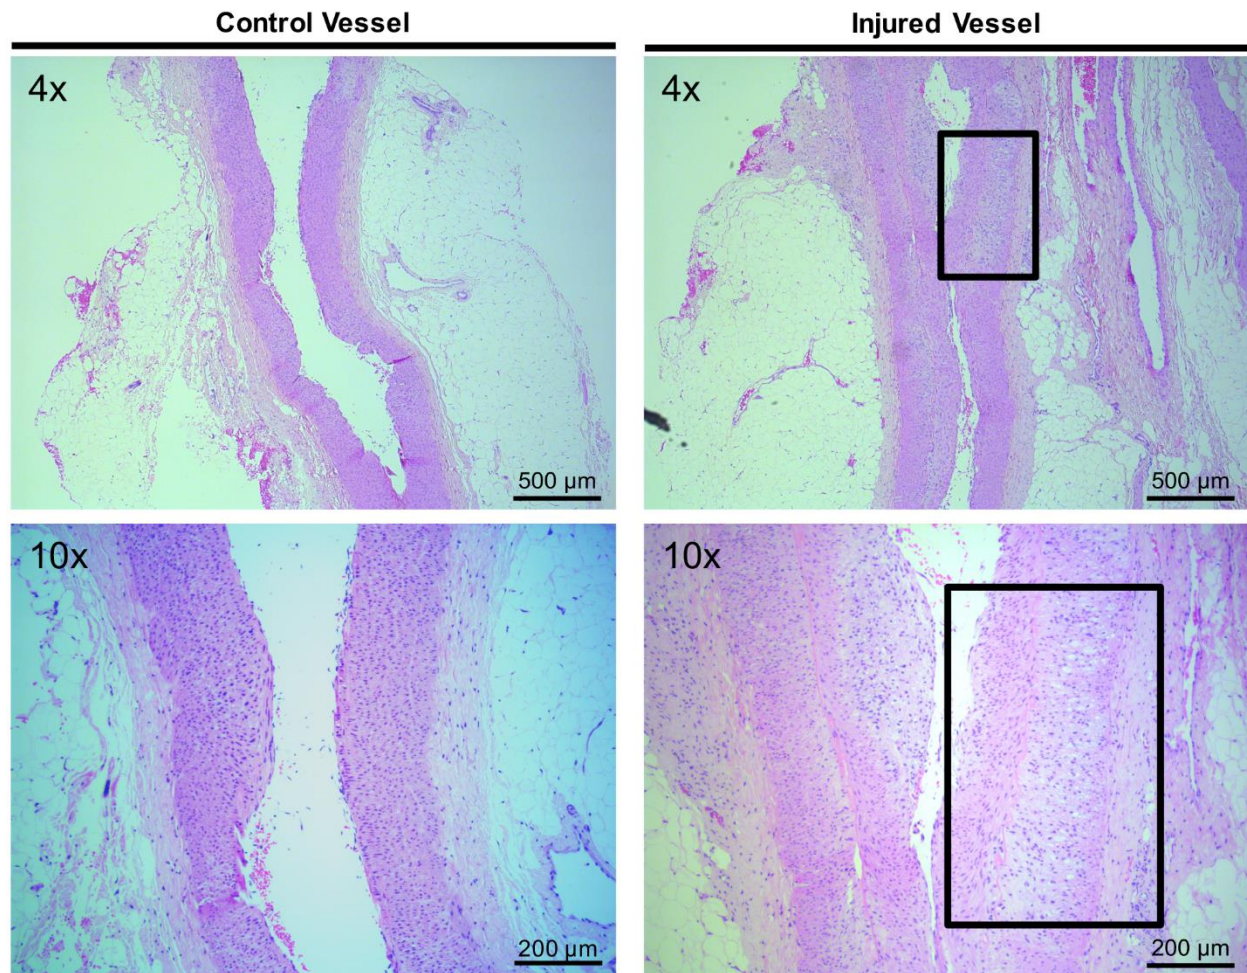
Supplemental Figure 6. Hematoxylin and eosin (H&E) stain of the sham-operated (control) femoral artery (left) and injured femoral artery (right) in 4X (top) and 10X (bottom) magnification shows that feeding cholesterol-enriched diet and air desiccation produced a focal thickened neointima in the area of previous air desiccation that was comprised of foam cells, and vascular smooth muscle cells. The duration of cholesterol diet was too short to see lesions induced in peripheral arteries other than the one with air desiccation.

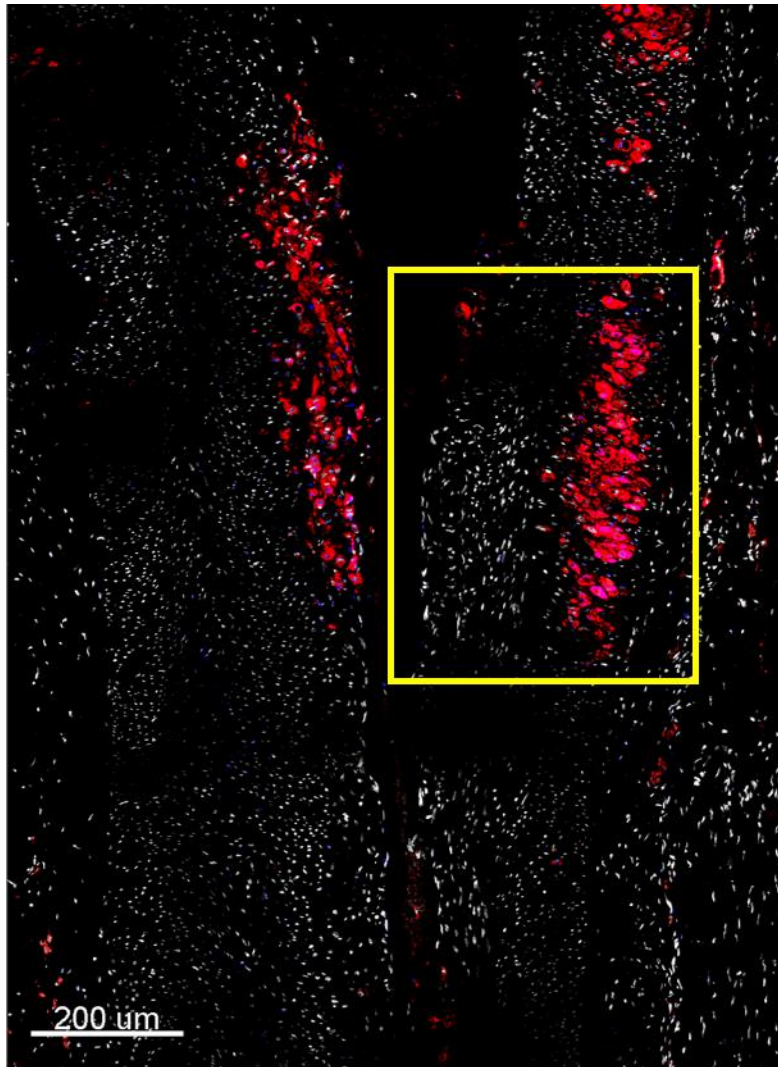
HIF-1 α & Ram-11 overlay – area scan

Supplemental Figure 7. Area scan containing the injured femoral artery depicted in Figure 4 shows the presence of both deep and superficial macrophages in RAM-11 staining which are co-localized to HIF-1 α staining. However, only deep macrophage-rich area is pimonidazole positive, as displayed in Figure 4(C). The color code is as follows: DAPI, white; RAM-11, red; HIF-1 α , blue.

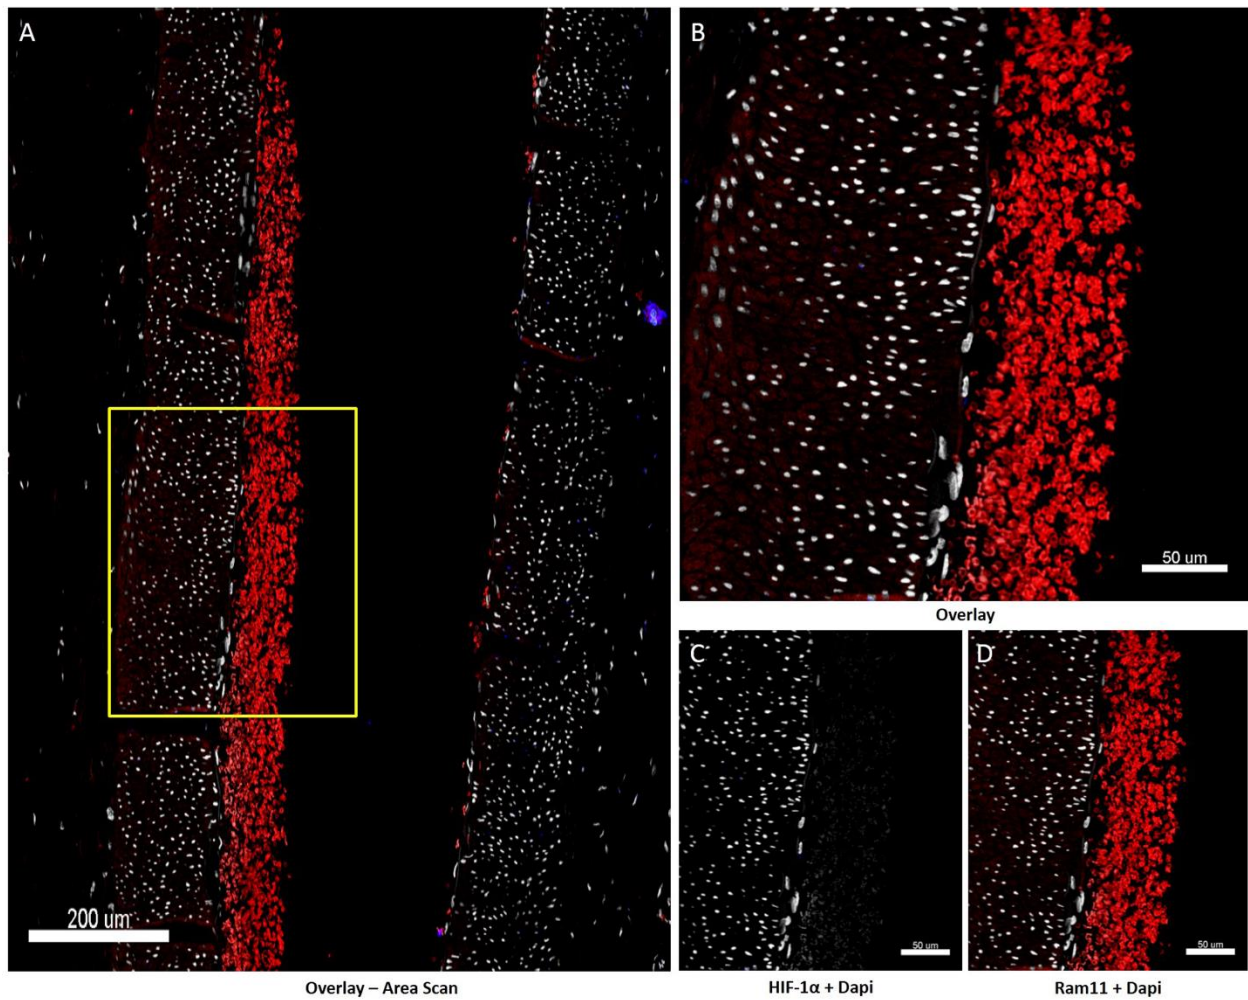
Supplemental Figure 8. Immunofluorescence images of the sham-operated femoral artery showing that neither Ram-11 nor HIF-1 α were positively stained in this region. Red observed is red blood cells (non-nucleated). Images of pimonidazole staining from the adjacent section (no positive results) were not included in this figure.
