Supporting Information

Figure S1 Photos of humidifiers used in testing

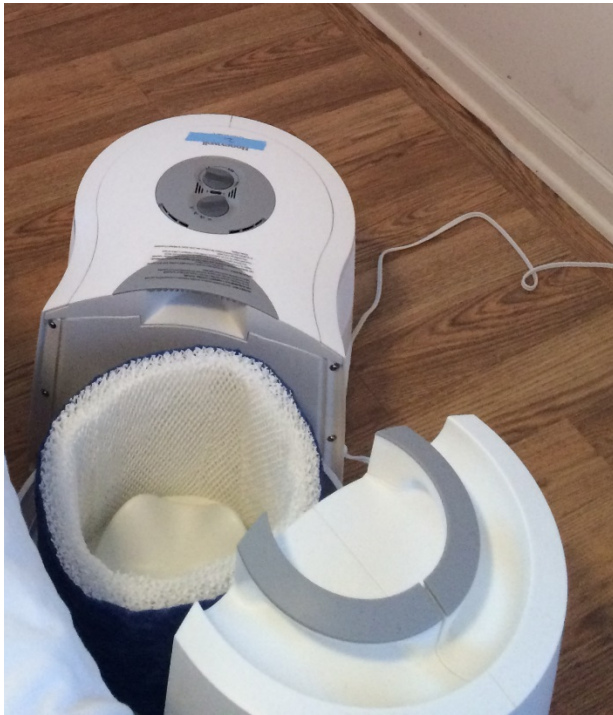
Sponge/Evaporative type humidifier

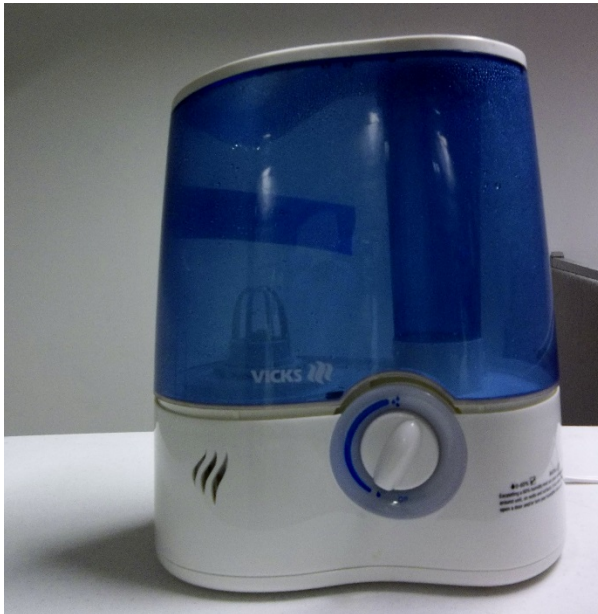
Ultrasonic humidifier

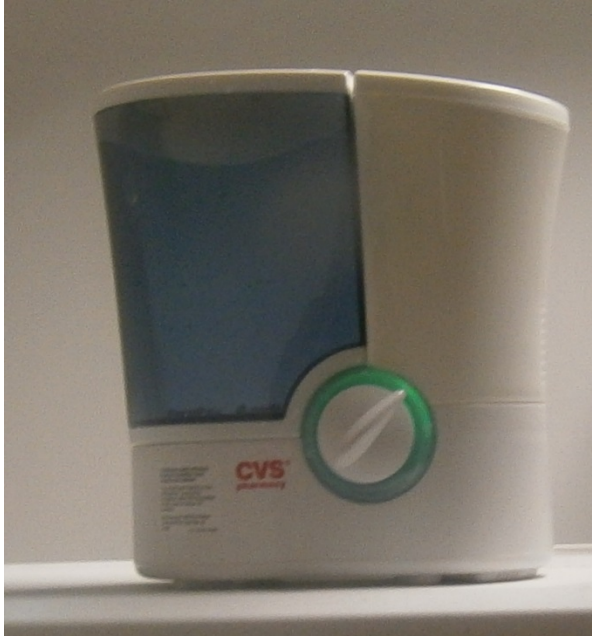
Heated vaporizer
