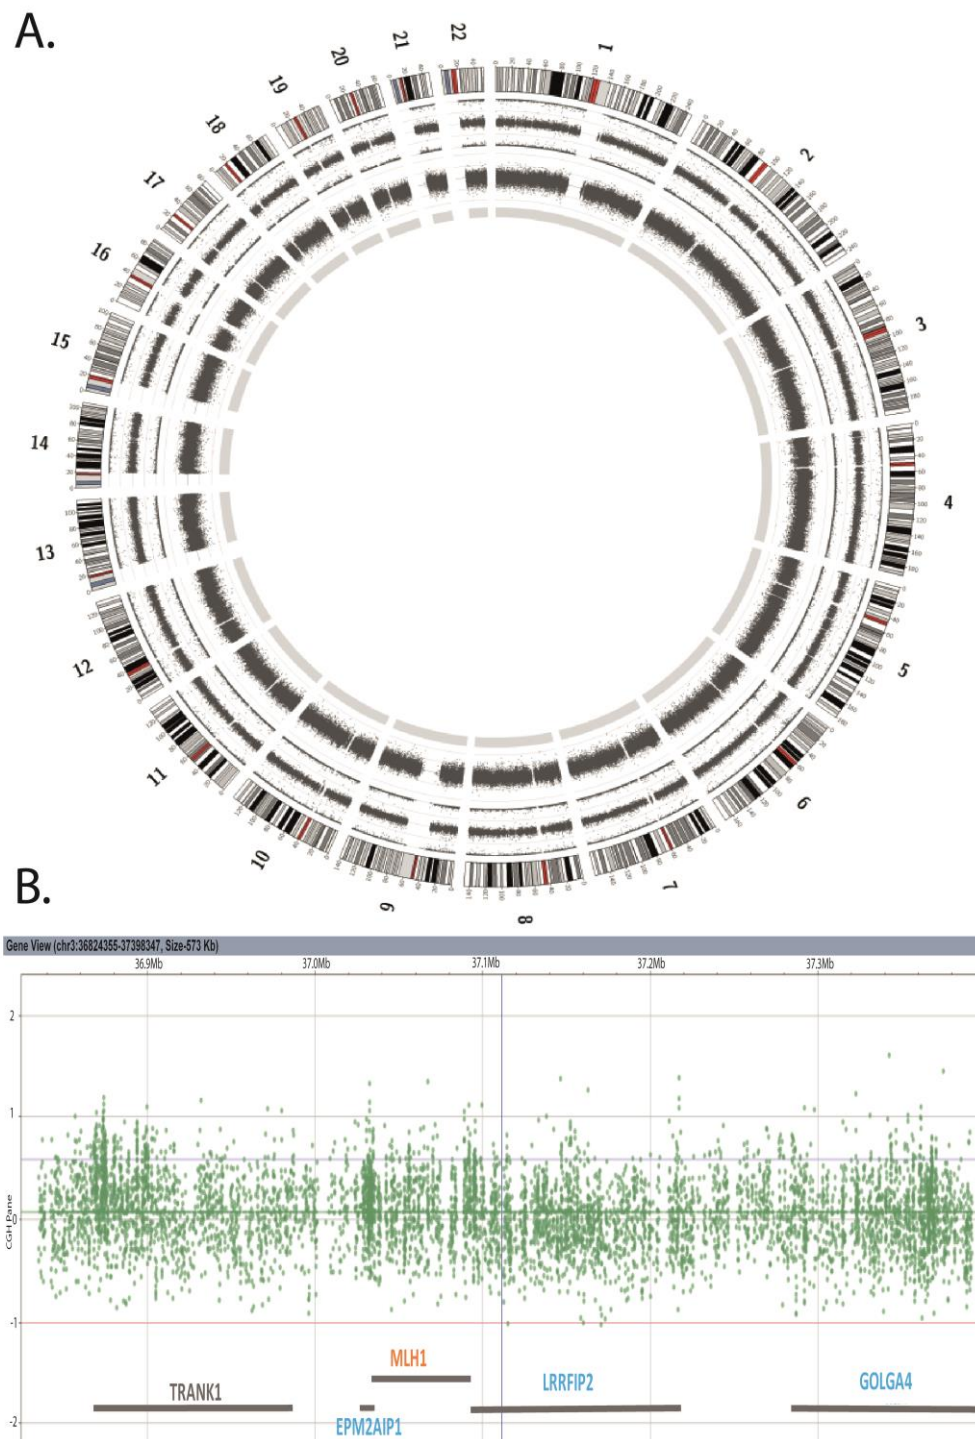
Figure S5. Analysis of structural aberrations in case 29. A) Genome-wide SNP array profiling of blood DNA from case 29 is shown as Circos plots. Circos plot was divided into three concentric circles. Chromosomes are represented at the external circle with their centromeres painted in red. In the middle circle, external allelic peaks mark homozygous SNPs and internal allelic peaks heterozygous ones. Internal circle tracks log₂ copy number lane: middle points indicate diploid genomic material; upper points, gains of genomic material and lower points, losses.

Patient 29 displayed a diploid pattern throughout her genome without signs of loss-of-heterozygosity. **B)** CNV analysis in the *MLH1* region of patient 29 by custom CGH array. Genes located in the analyzed region are represented at the bottom of the figure. Probes are displayed as green dots in a log₂ graph. Gains and losses of genetic material are considered when more than five consecutive probes reach values of 2 or -2, respectively. No CNV abnormalities were identified.
