Supplementary Data

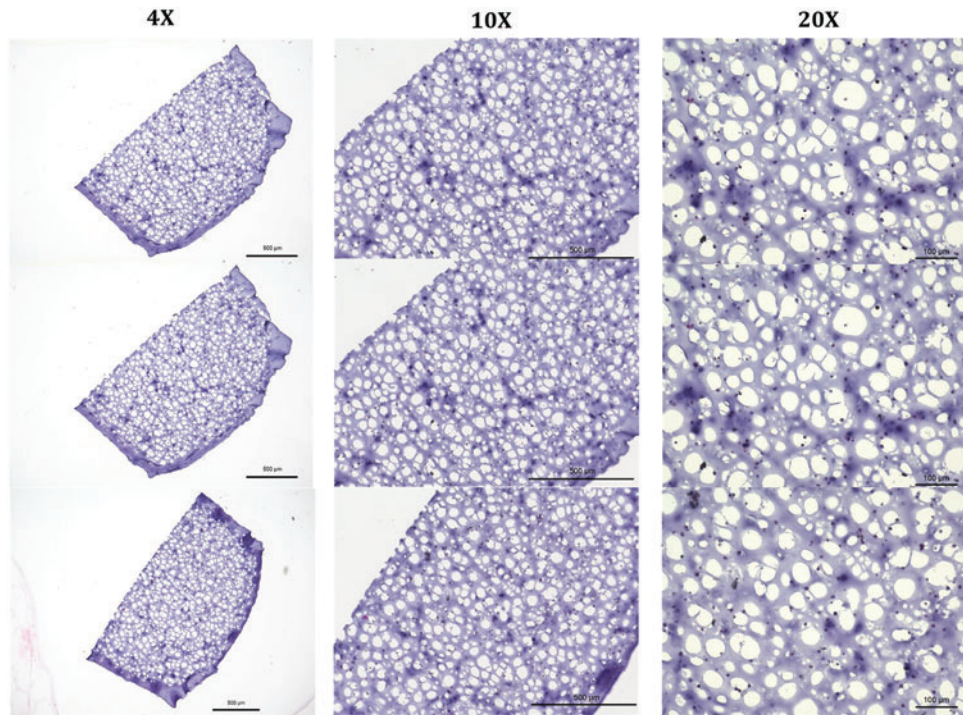
SUPPLEMENTARY FIG. S1. H&E staining sections of scaffolds with macrophages. Coronal sections of scaffold with 800,000 macrophages stained with H&E showing an even distribution of macrophages throughout different depths of the scaffold. H&E, Hematoxylin and Eosin.
