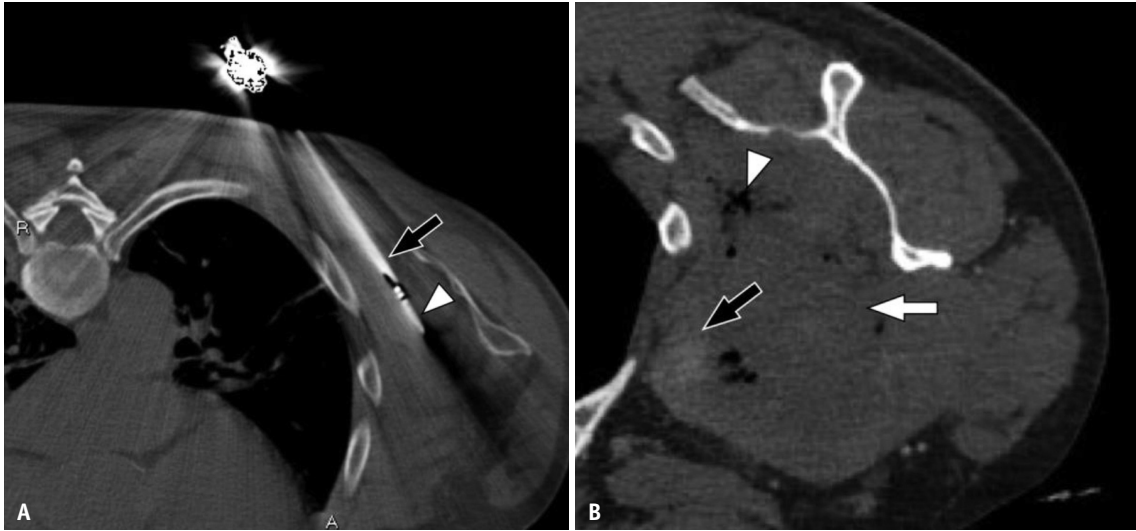
Supplementary Fig. 3. Ablation technique and outcome in a 76-year-old male with desmoid tumor of the periscapular region.
A. Axial CT image shows the location of the vertebroplasty needle used as an introducer (arrow) and the microwave probe (arrowhead).
B. Gas bubbles (arrowhead) and hematoma (black arrow) can be seen on the control CT after tumor ablation (white arrow). CT = computed tomography
