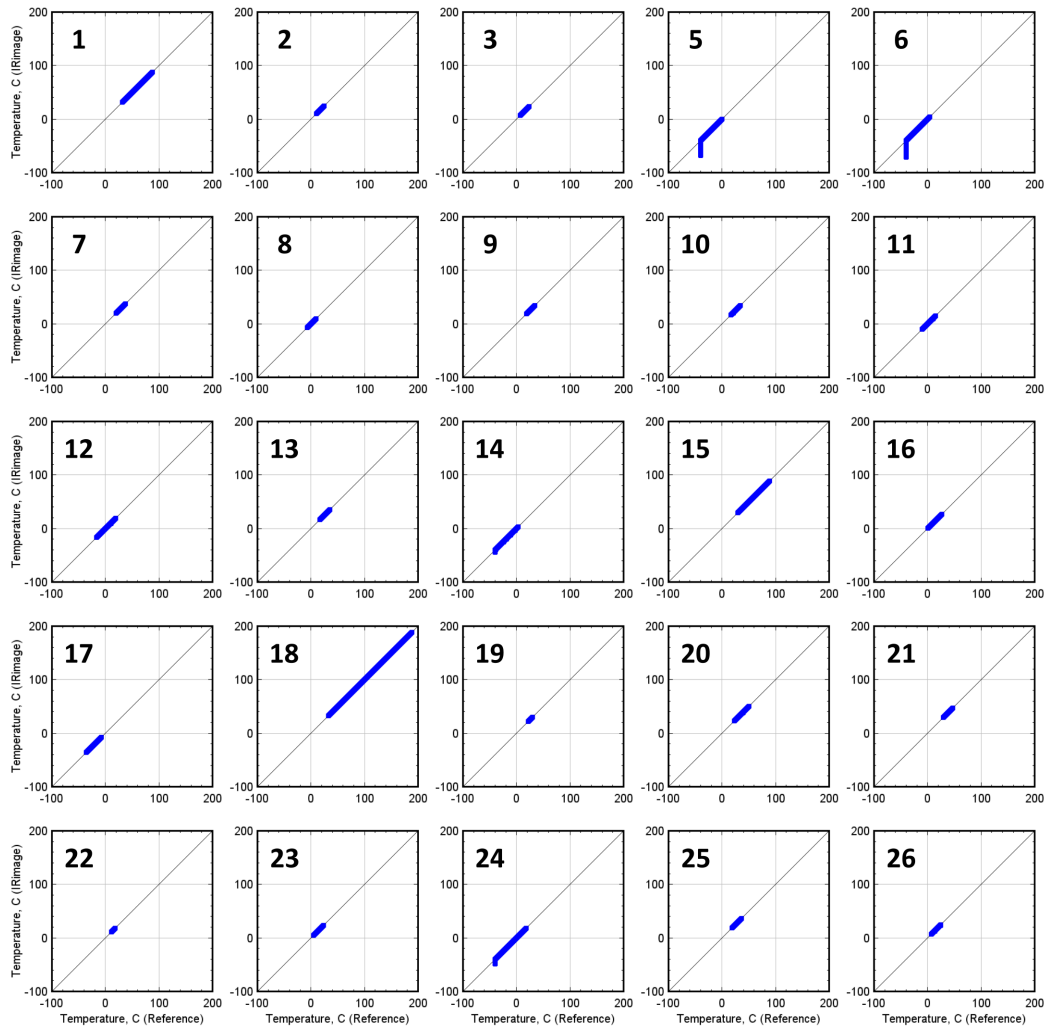
Figure S1. Results of the comparison between IRimage and FLIR Tools. Scatter plots comparing the temperature values of all the pixels in each image obtained using IRimage vs. the reference temperature values obtained from the original images using the manufacturer's software FLIR Tools. Data is shown for 25 out of the 26 tested images; comparison was not possible for image #4 because it could not be opened with FLIR Tools. Information about the images used is available in Table S2.
